Arrowtown
GOLF CLUB

LONG TERM GOLF COURSE PLAN

Final Draft 11 March 2022

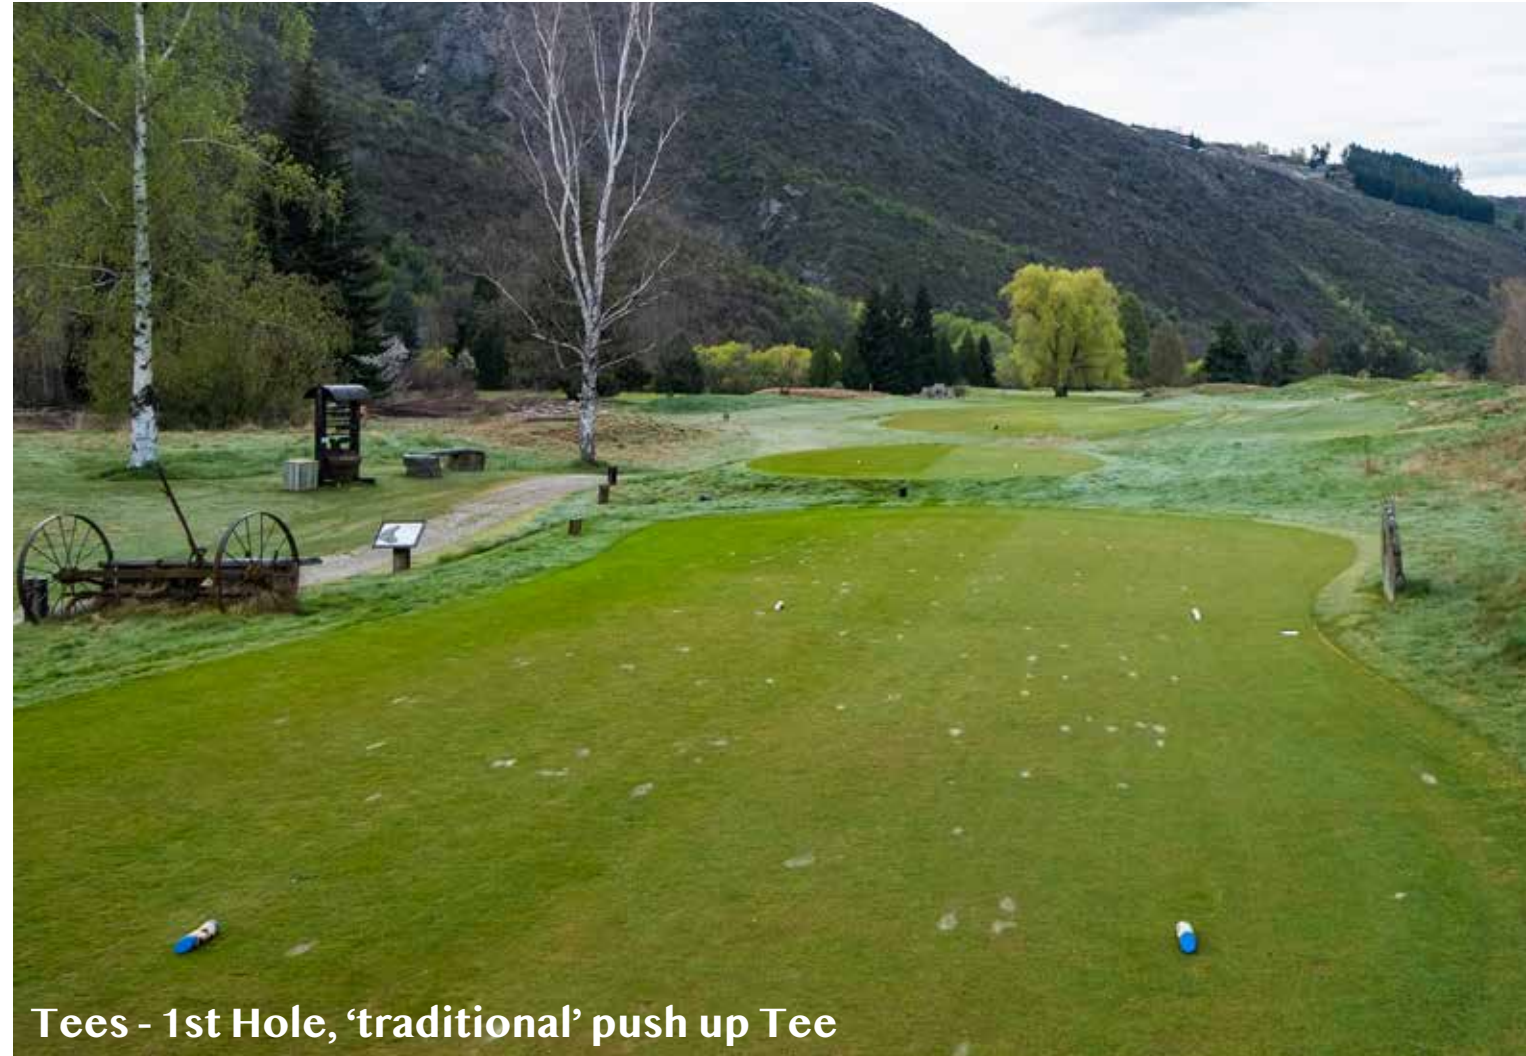
Tees - 1st Hole, 'traditional' push up Tee

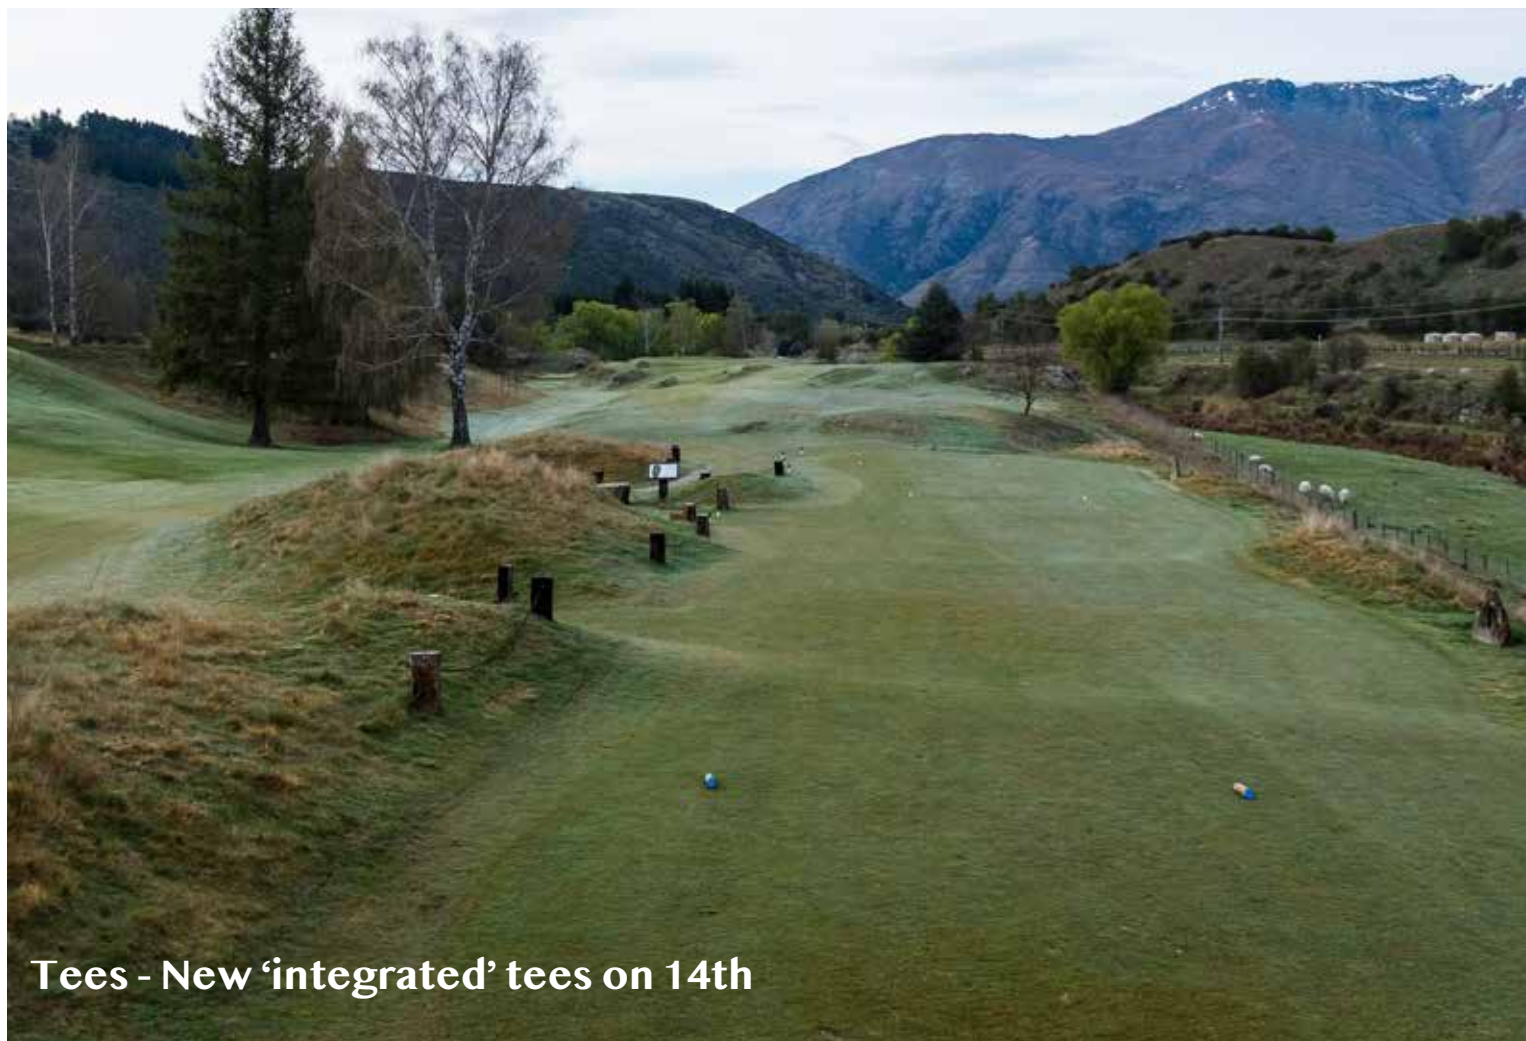
Tees - New 'integrated' tees on 14th

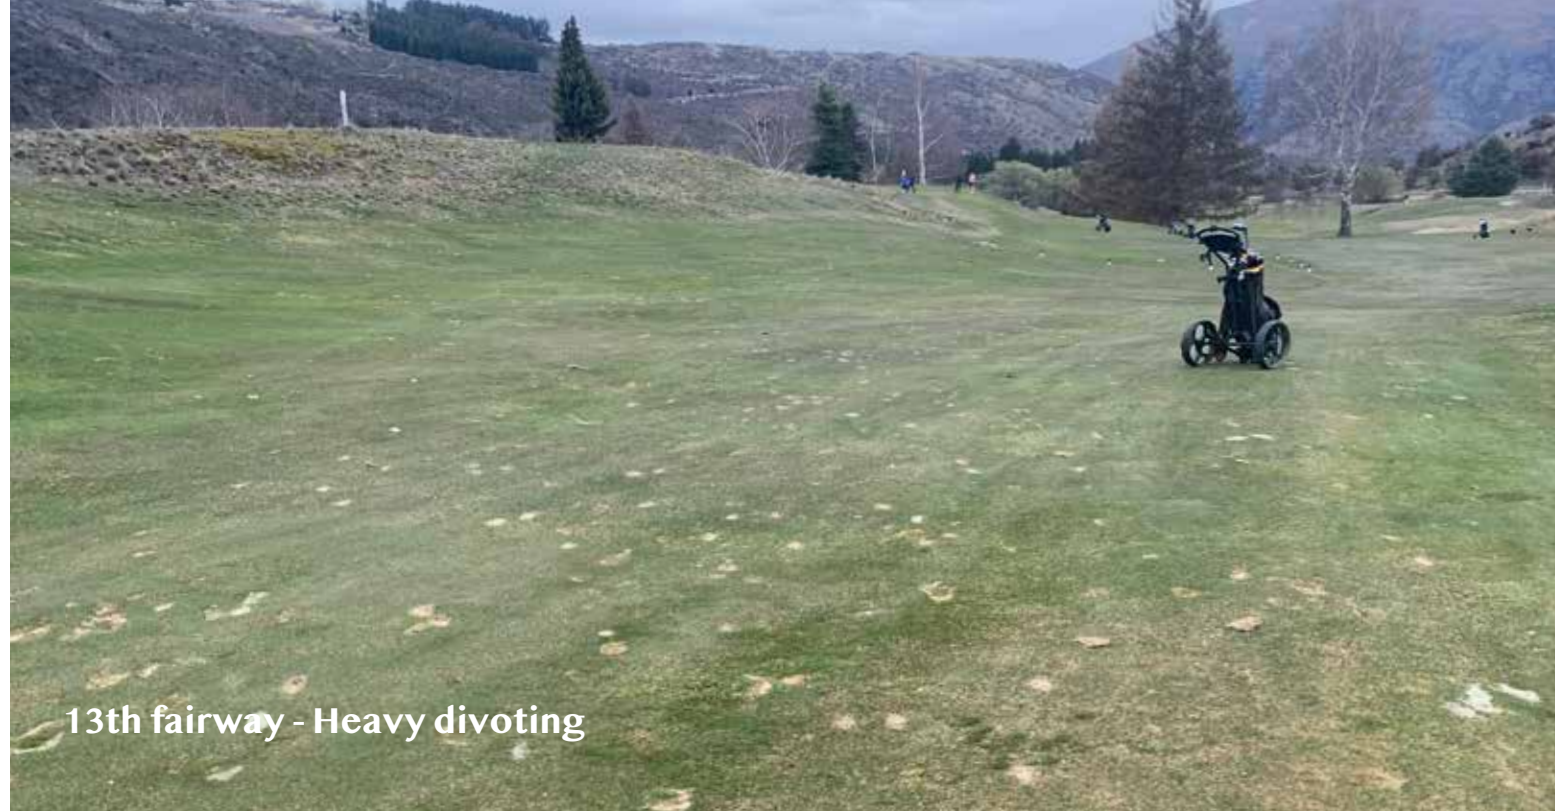
13th fairway - Heavy divoting

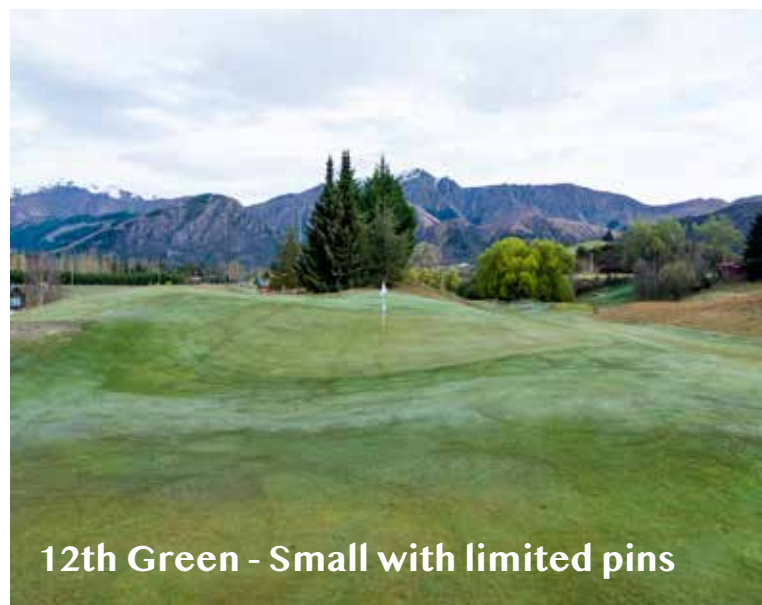
12th Green - Small with limited pins

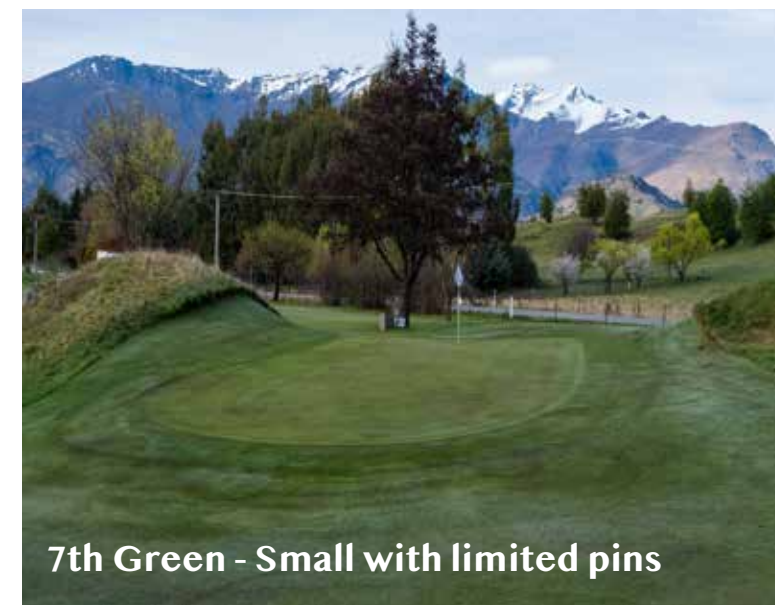
7th Green - Small with limited pins

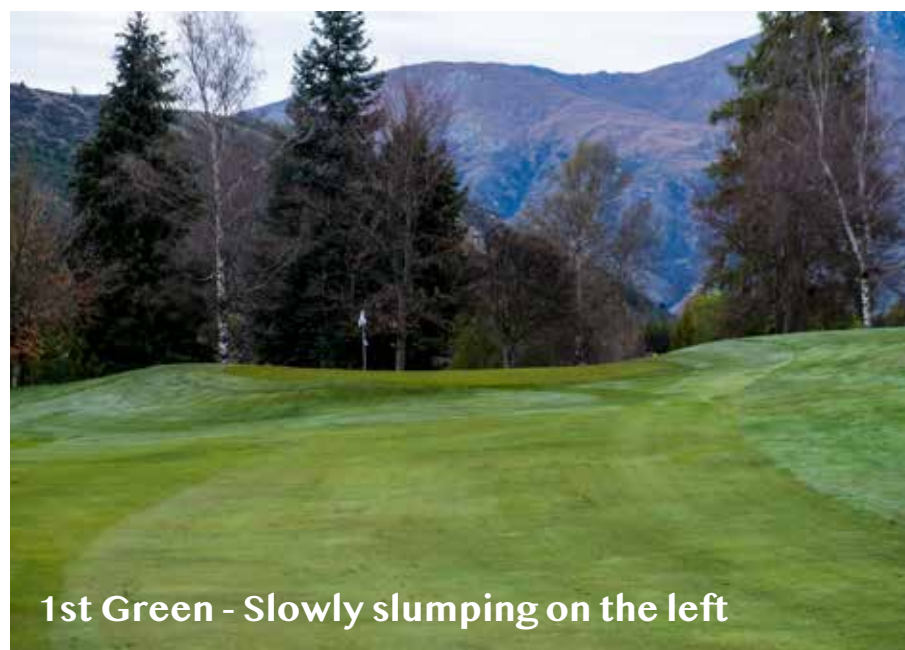
1st Green - Slowly slumping on the left

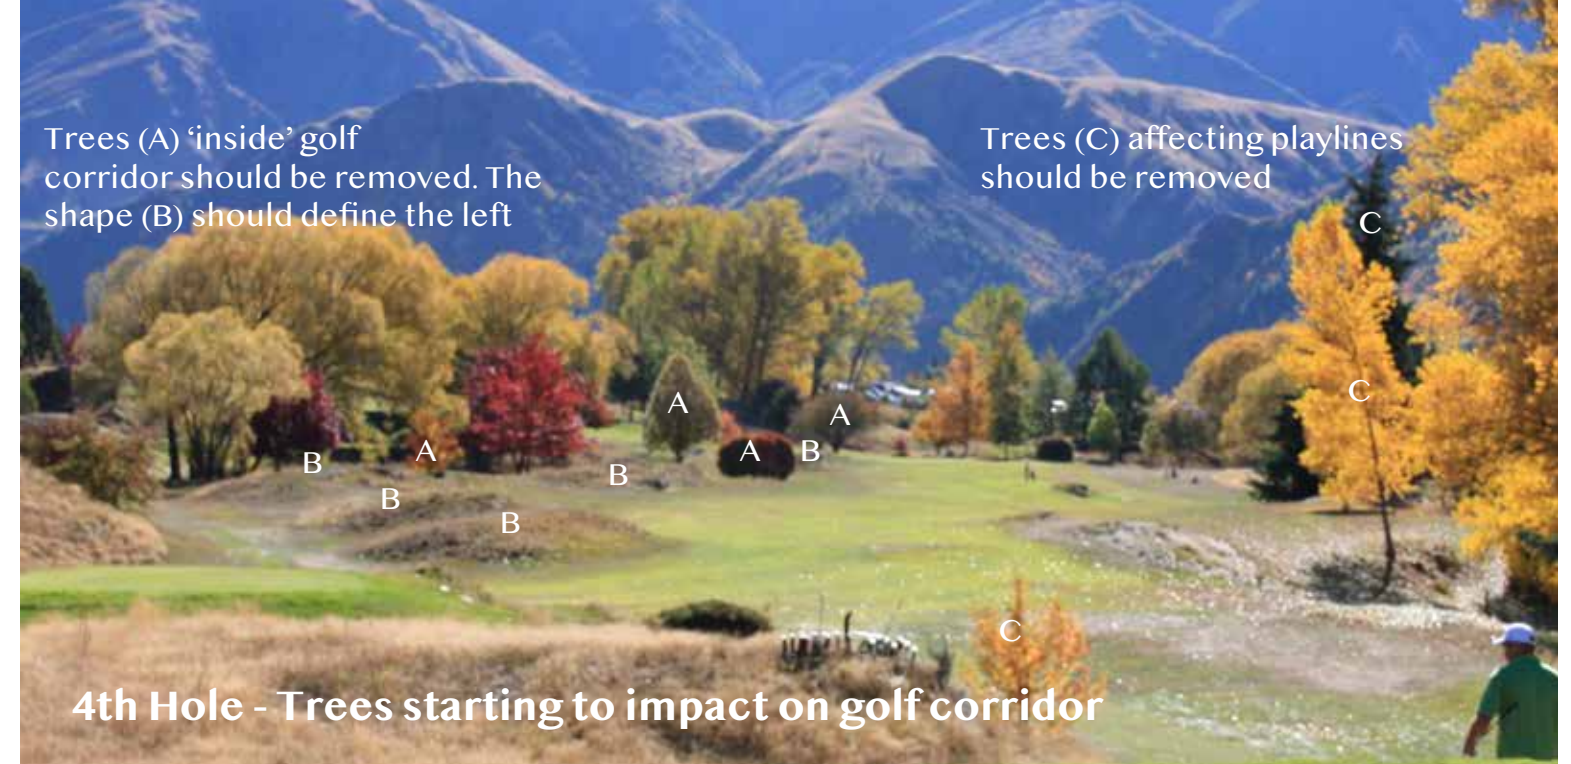
4th Hole - Trees starting to impact on golf corridor

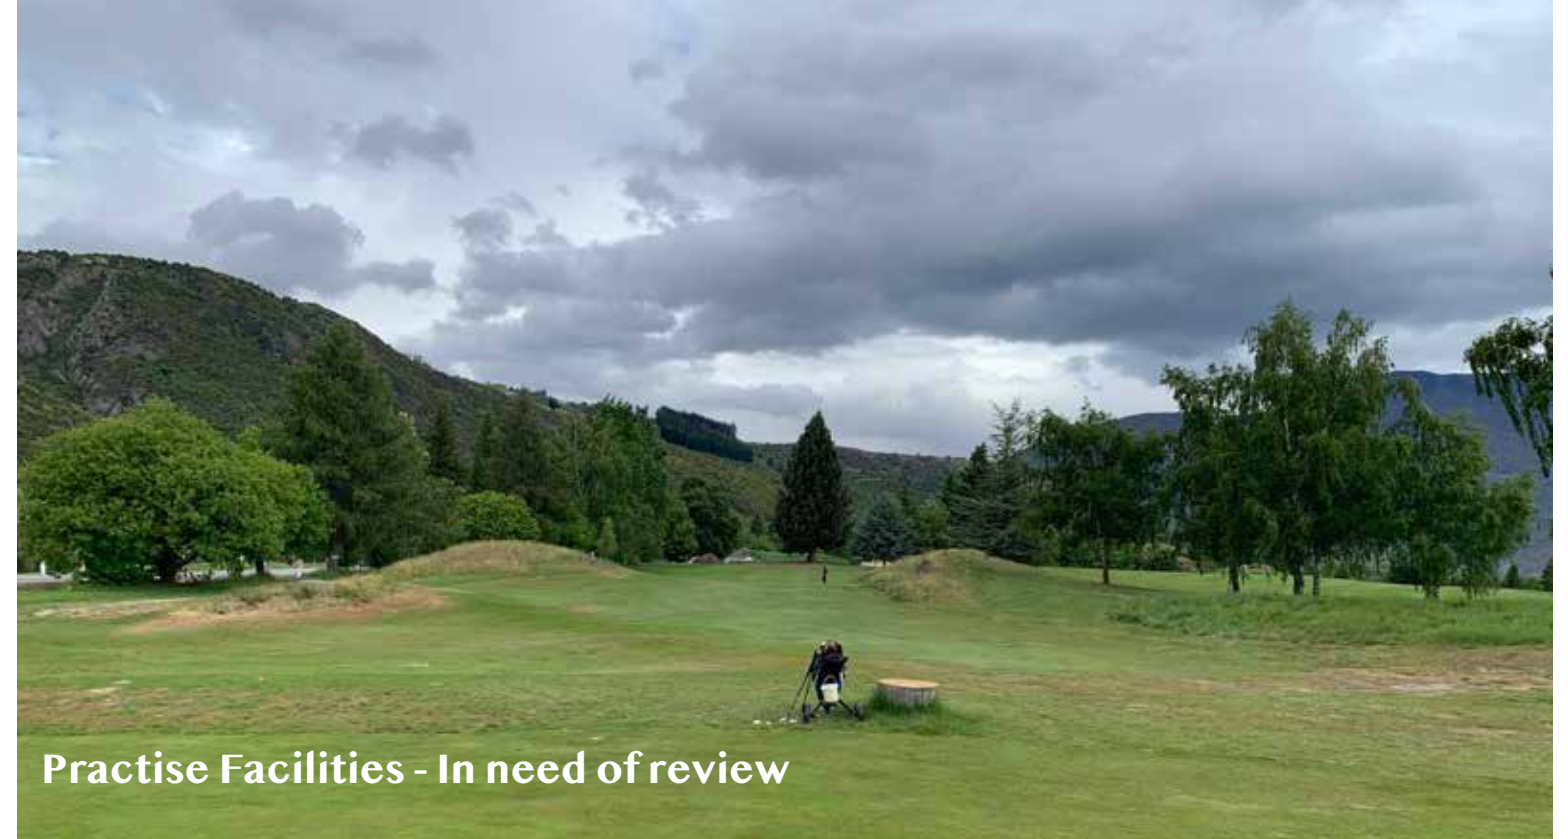
Practise Facilities - In need of review

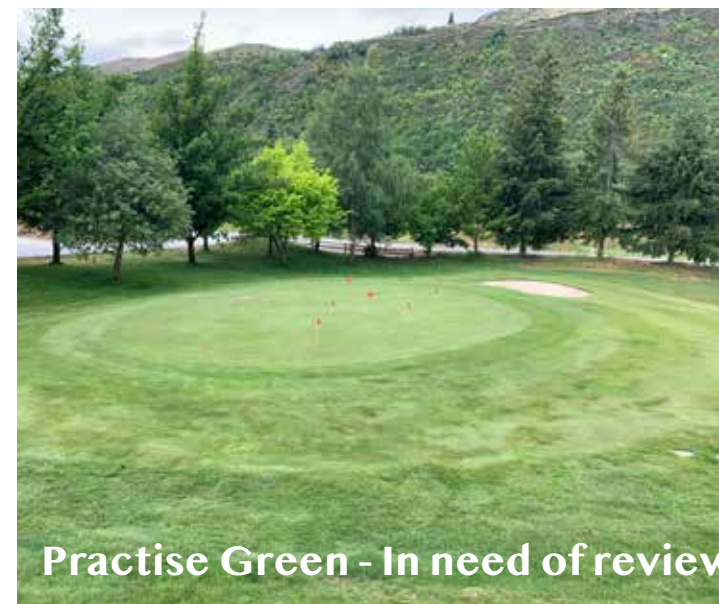
Practise Green - In need of review

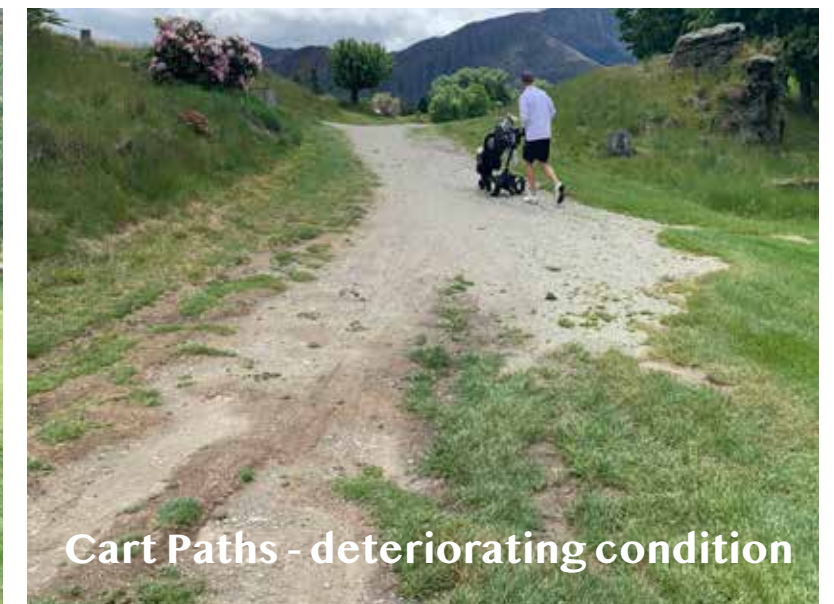
Cart Paths - deteriorating condition

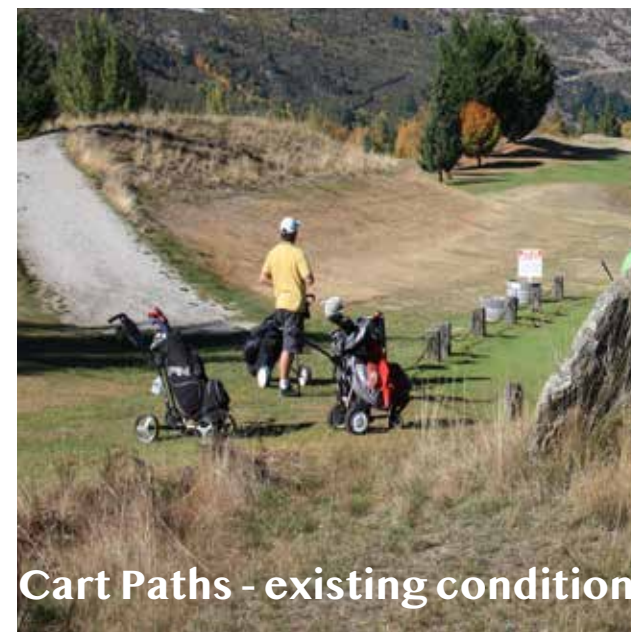
Cart Paths - existing condition

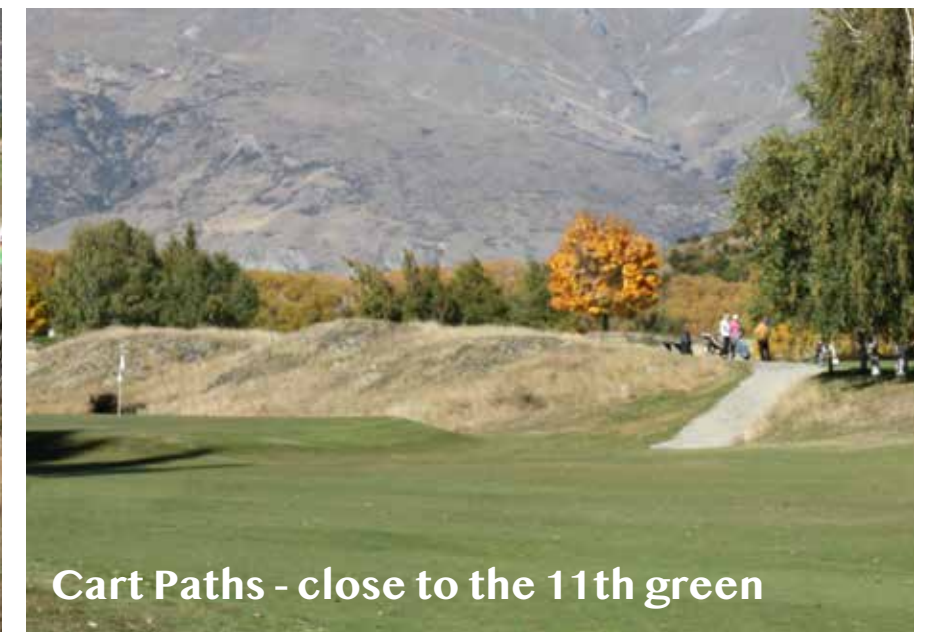
Cart Paths - close to the 11th green

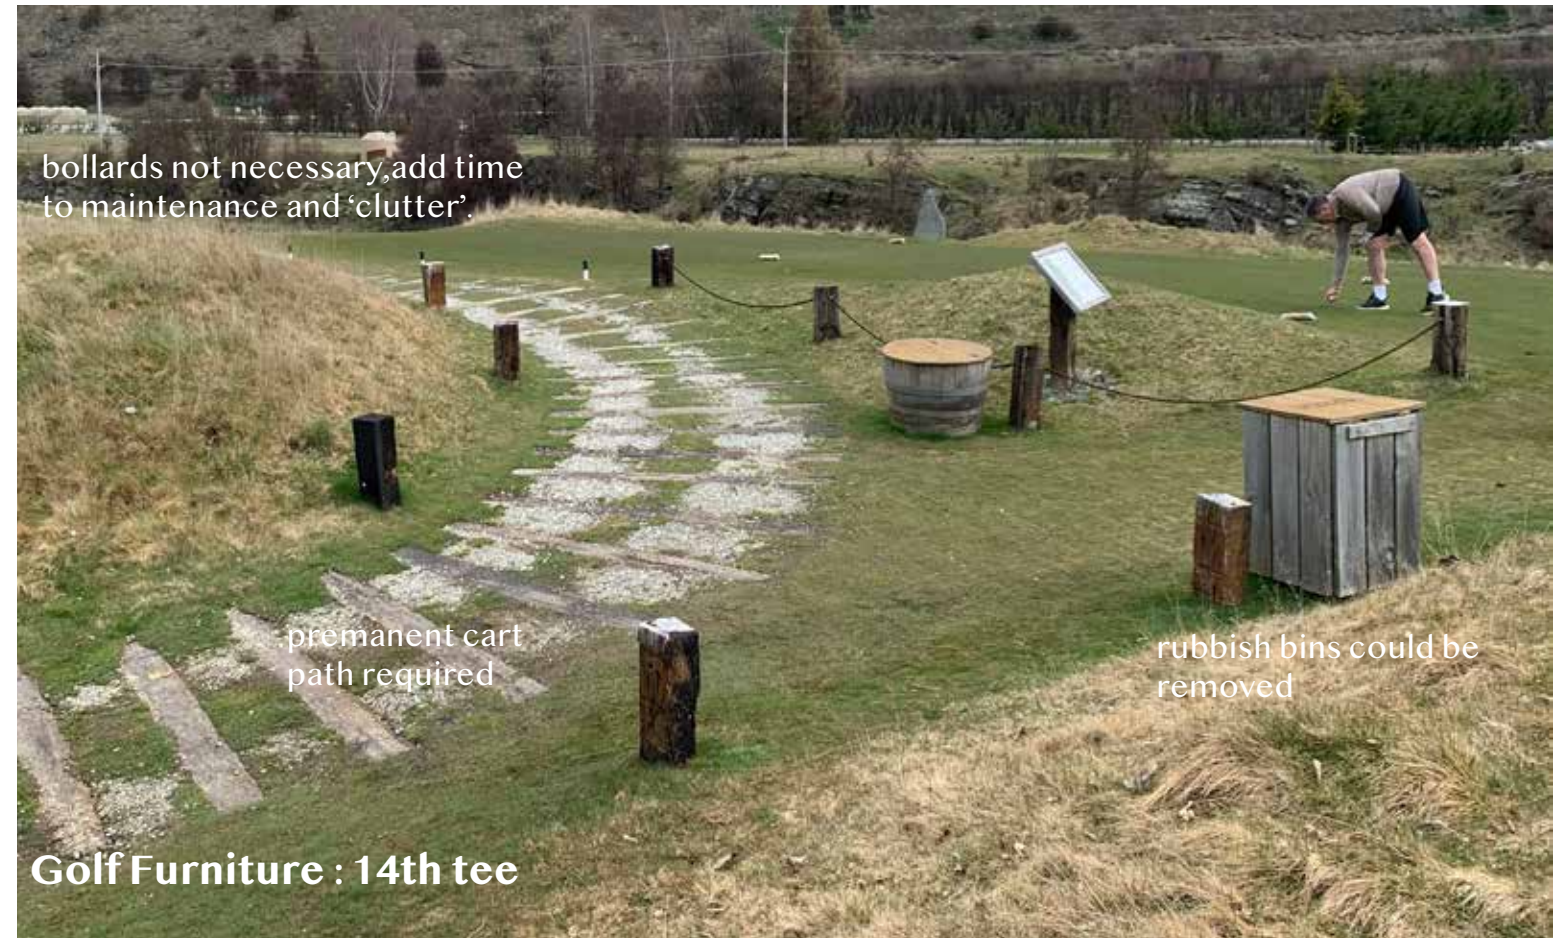
Golf Furniture : 14th tee

bollards not necessary, add time to maintenance and 'clutter'

rubbish bins could be removed

permanent cart path required

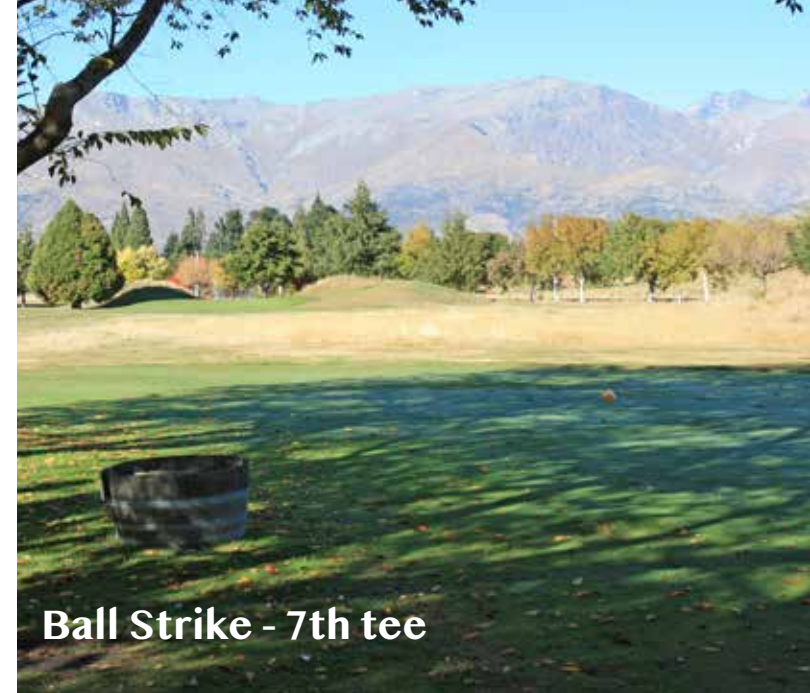
Ball Strike - 7th tee

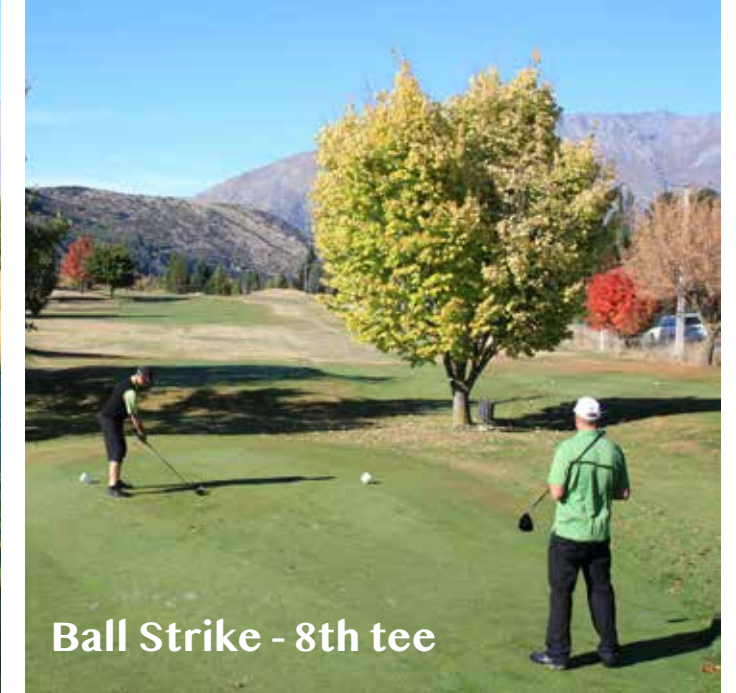
Ball Strike - 8th tee

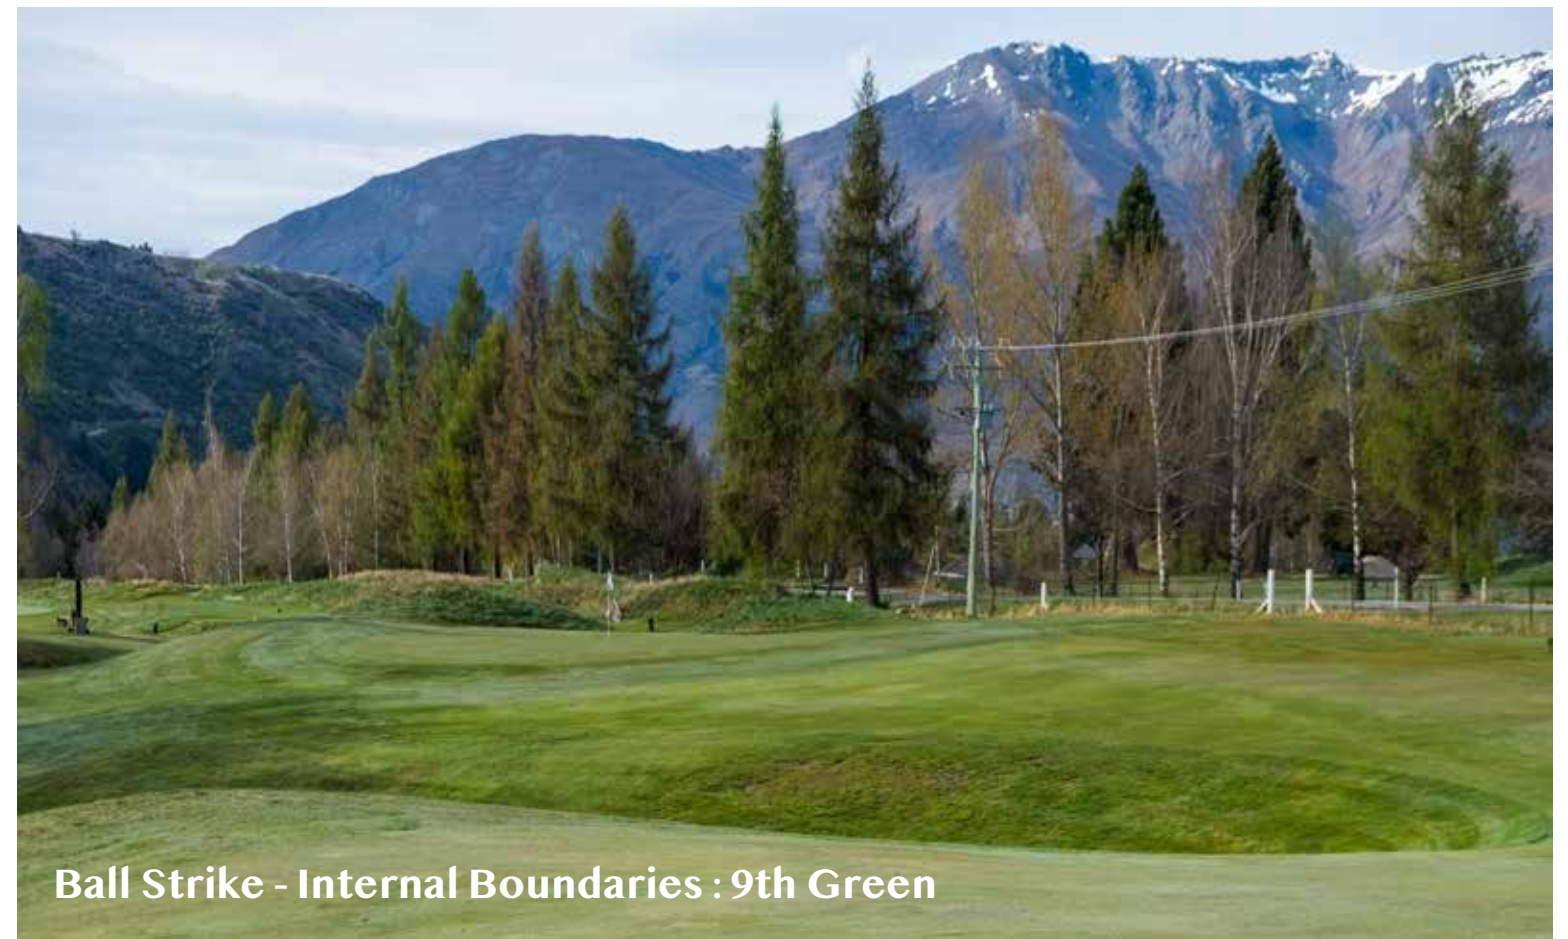
Ball Strike - Internal Boundaries : 9th Green

access off the 9th green, (B). The golfer currently has to walk back down the fairway to get to the access. Logic would suggest the golfer exit the green from the rear and onto the path/ access for the 1st tee, crossing point 'C', which minimises any hold ups for the golfers waiting to hit their second on the 9th fairway.

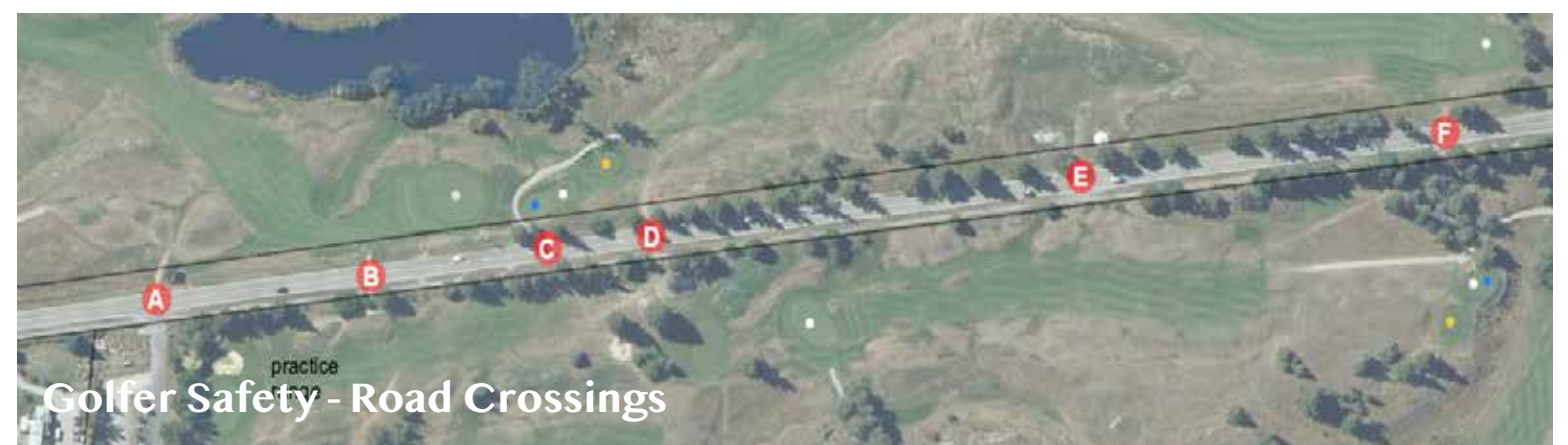
Centennial Ave is an 80km/hr road. Visibility is good in all directions as the road is straight. However, from a safety point of view, the fewer crossings the better. The circulation of the golfer could be improved by closing the

Golfer Safety - Road Crossings

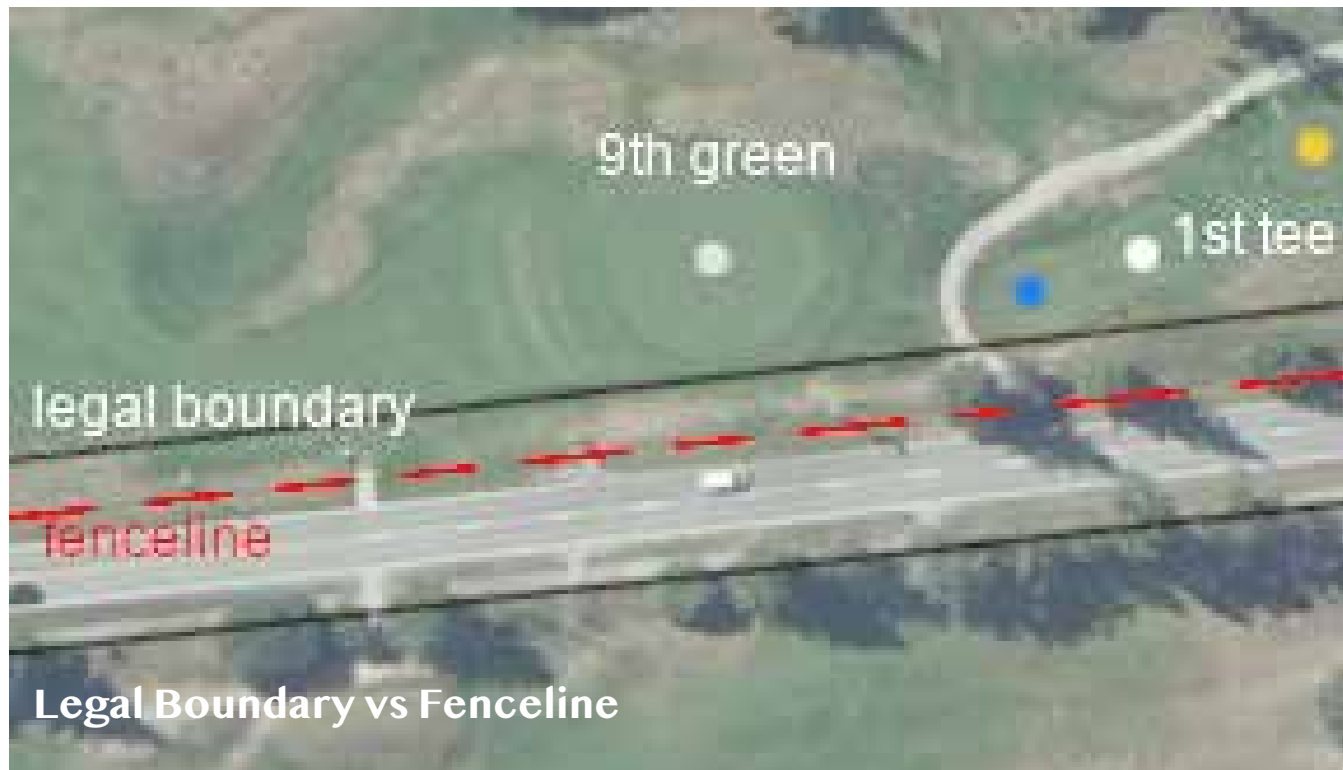
Please note : As mentioned previously, the fenceline is not the legal boundary. It is approximately 6-8m into the golf course

Legal Boundary vs Fenceline
