Arrowtown
GOLF CLUB

LONG TERM GOLF COURSE PLAN

Final Draft 11 March 2022

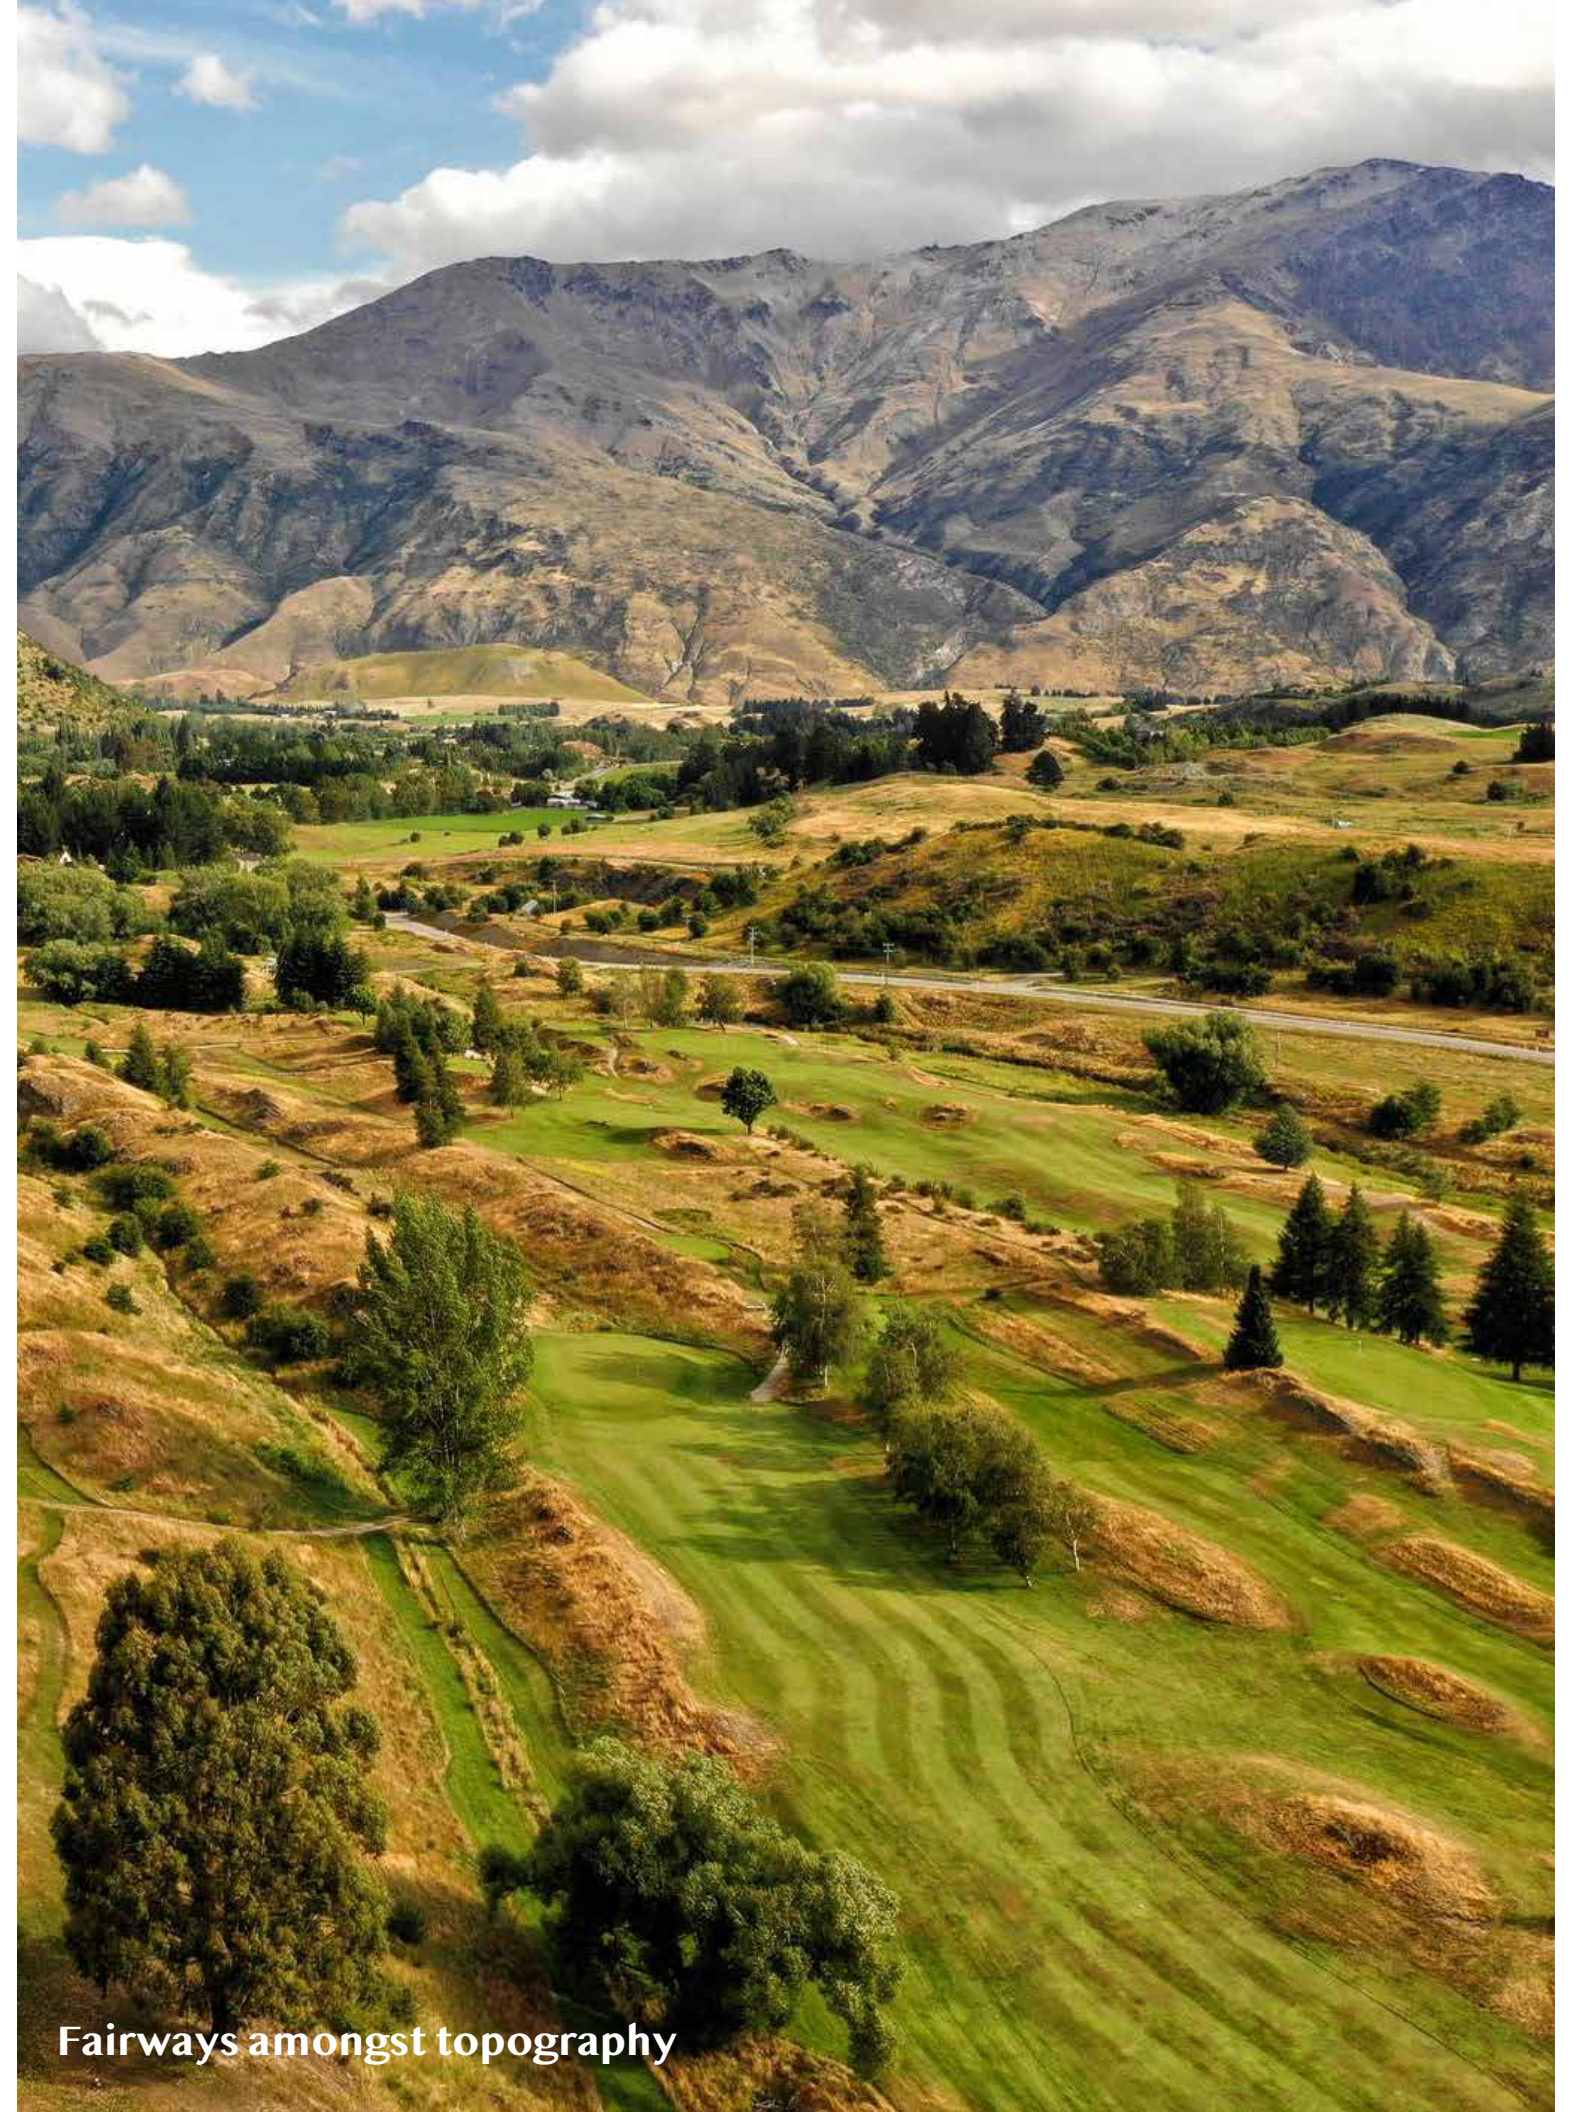
Fairways amongst topography

Fairway ‘profiles’ at Arrowtown are primarily dictated by the irrigation installation. Arrowtown has a single line of irrigation, making the fairways quite narrow. Topography is the other element dictating the fairway profile. The back 9 fairways were dictated by the topography long before the irrigation was installed. This topography has a tendency to guide and channel the golf ball. If you hit a fairway, or the sides of the valley then the balls generally end up being channelled into a similar area on the fairway eg. 11,12,13,14, 16 and 17. This concentrates play into a small area and with it the concentration of wear and tear and associated divoting. (refer Photo opposite). Variable teeing options help spread this divoting to aid recovery.

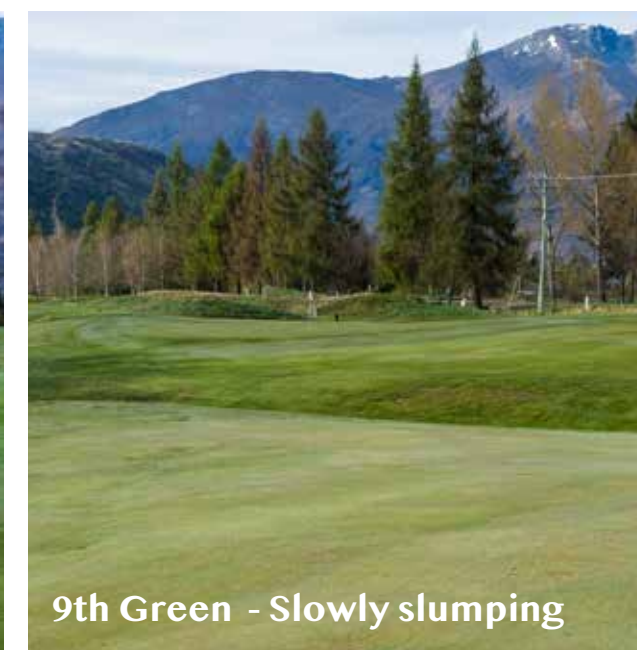
9th Green - Slowly slumping

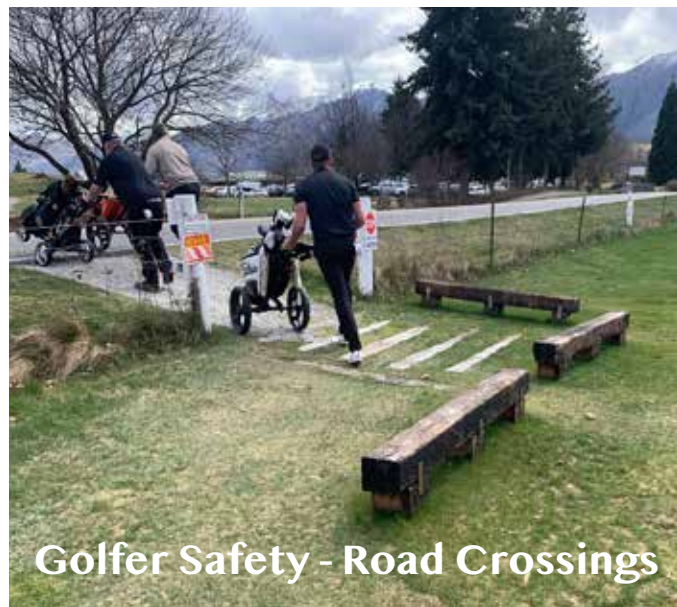
Golfer Safety - Road Crossings

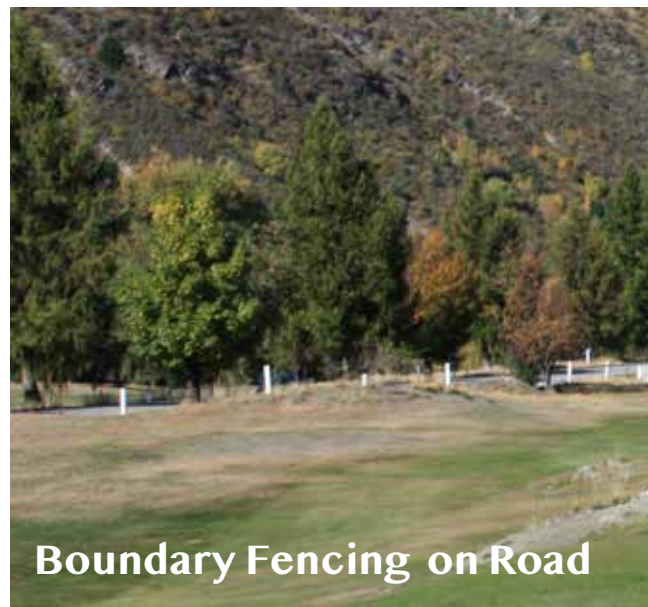
Boundary Fencing on Road

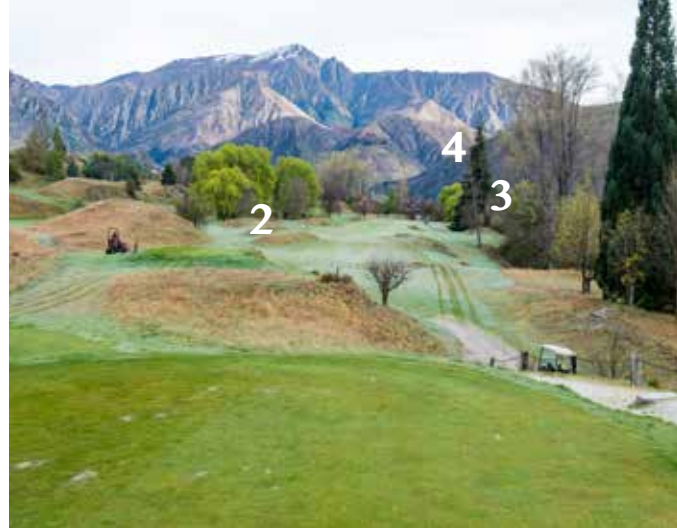
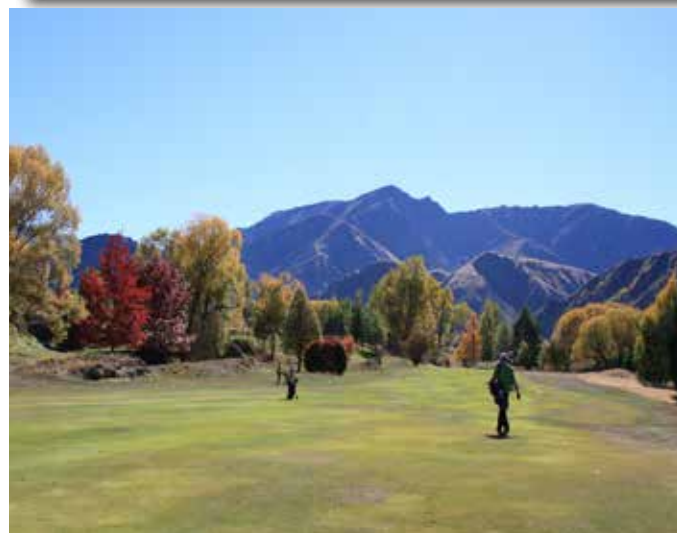
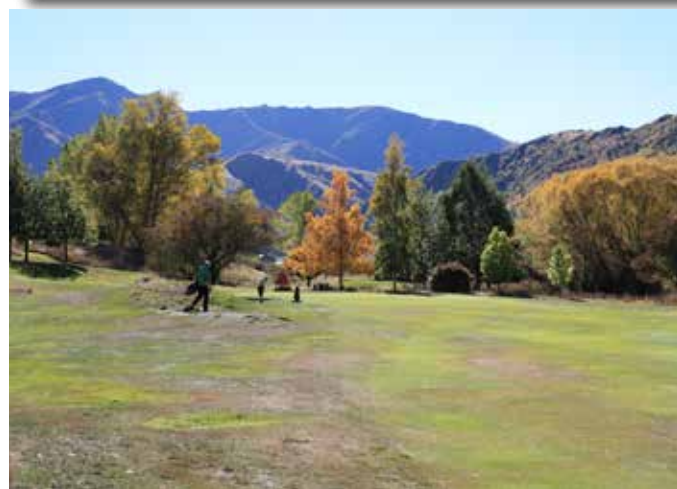
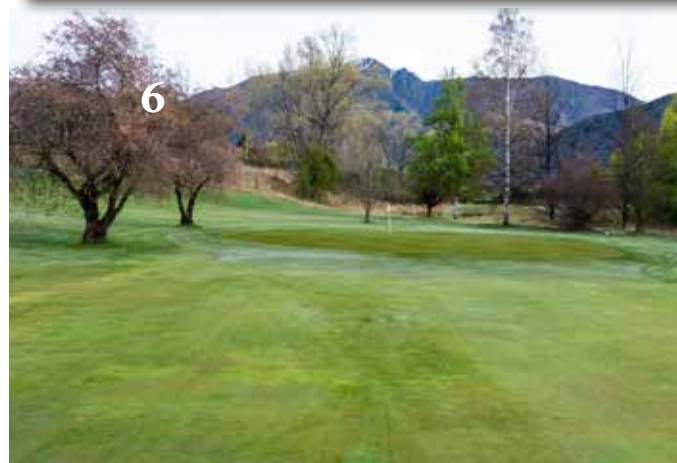
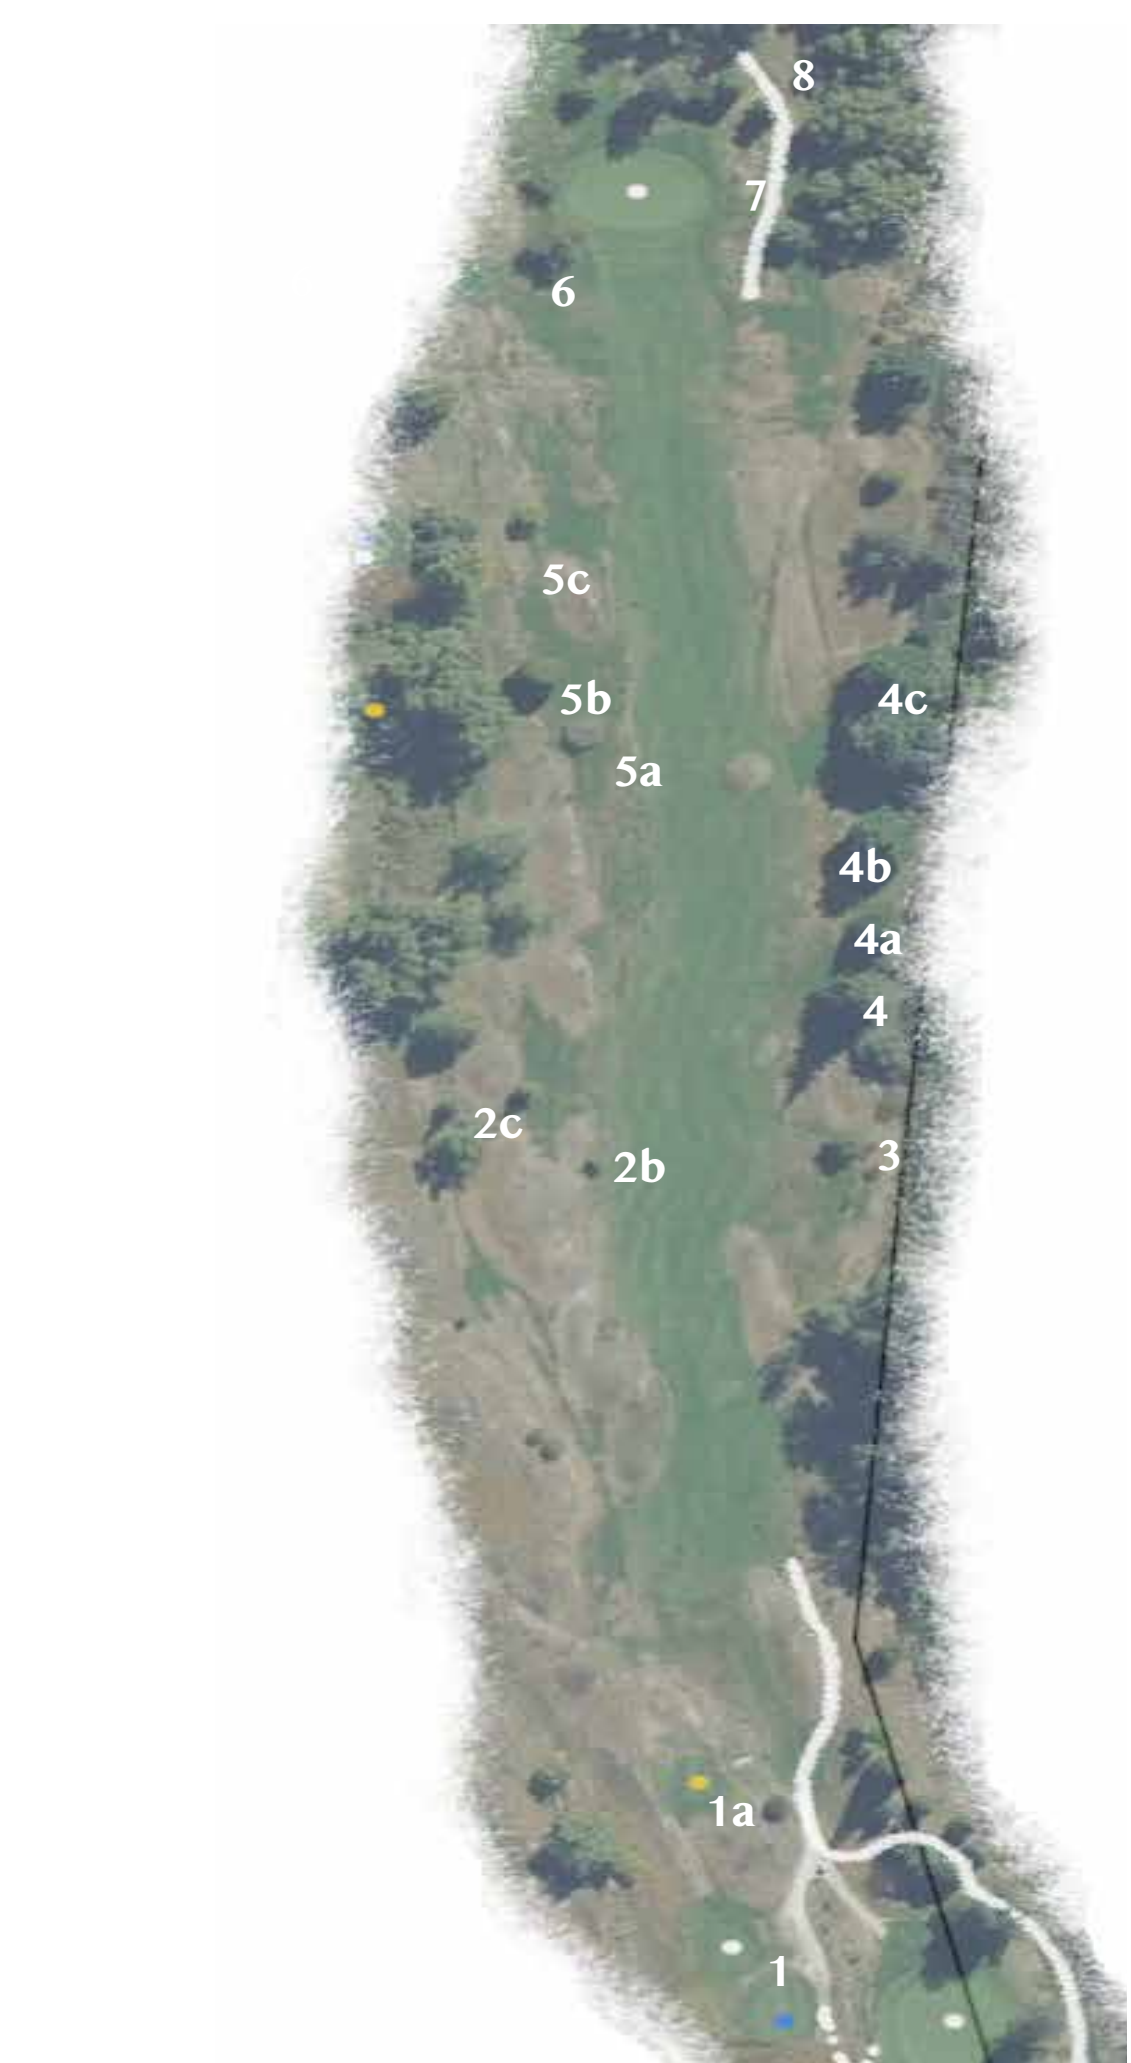
8. Drain wet area in front of tees that appears in winter, possibly a spring or seepage from pond.
9. Access for walking golfers only.
10. Remove silver birch.

1. Consider enlarging and extending the tees to area shown. This will give options for playing the hole a little shorter and from a different angle. It will also spread the wear and tear on the existing tee.

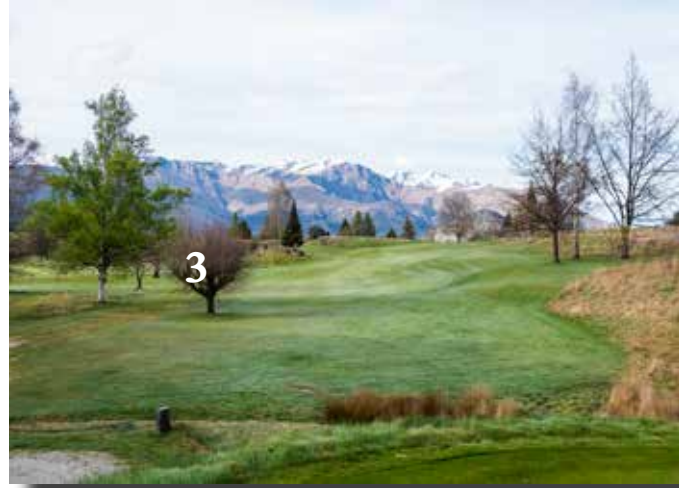
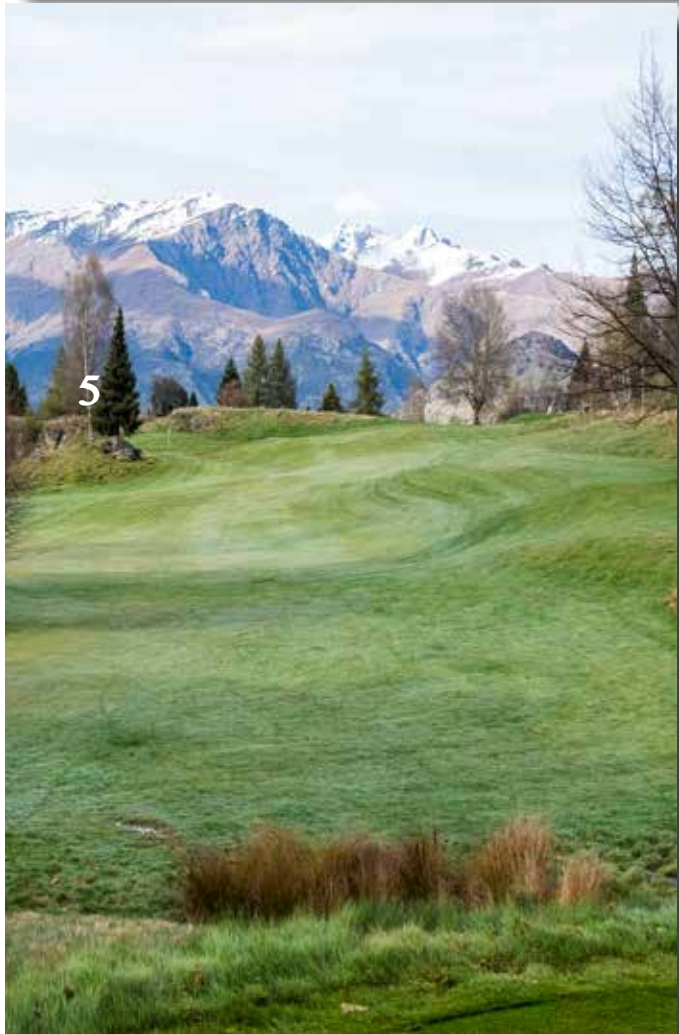
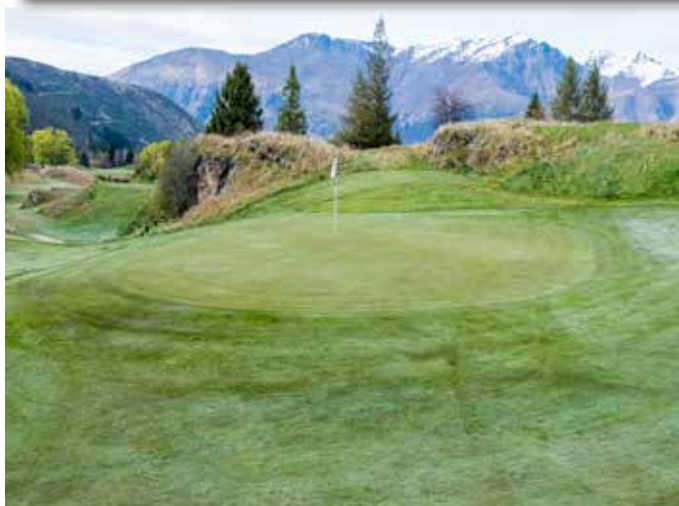
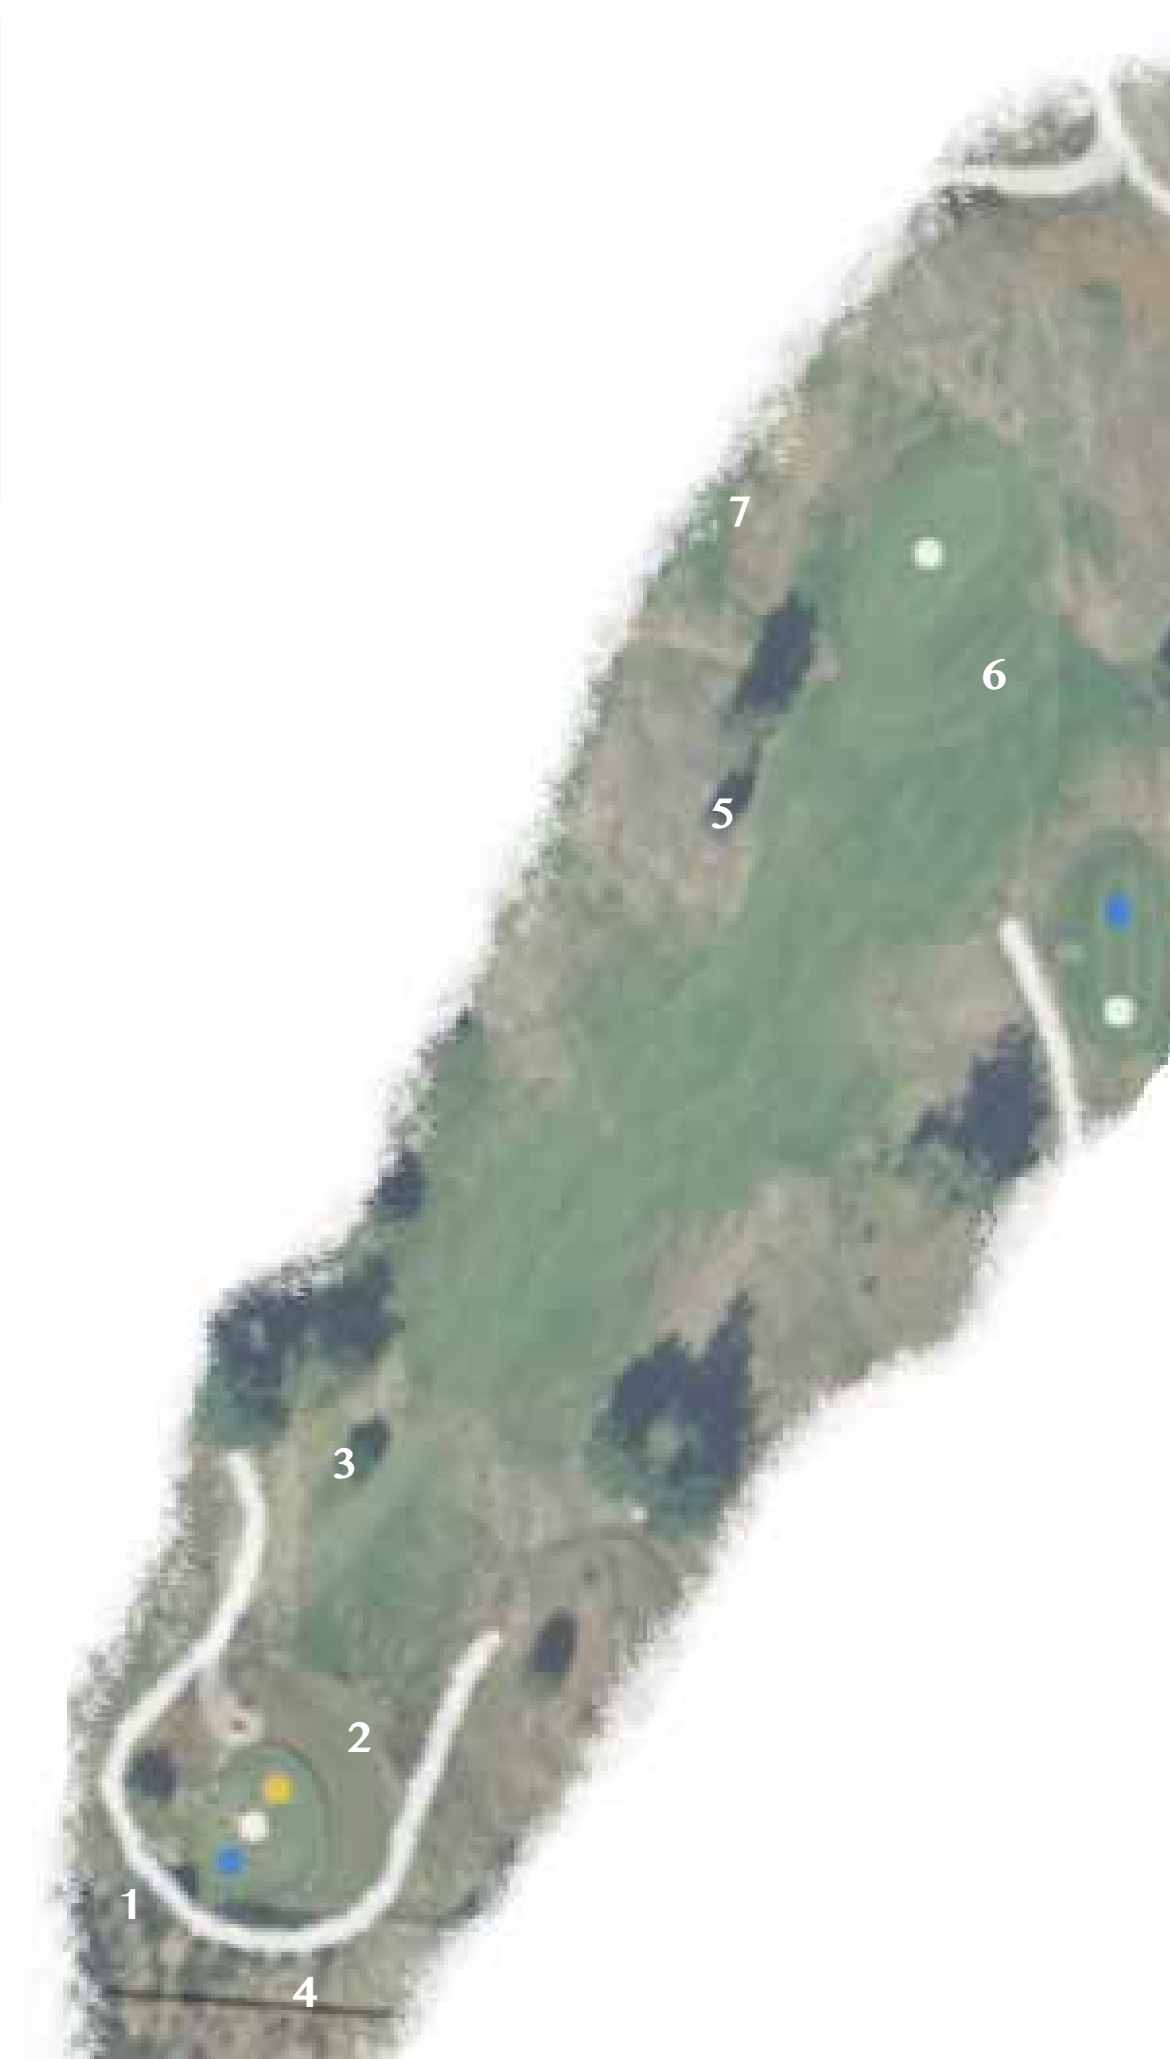
5. Consider removing the trees to reveal the rocky knob beneath..
6. There is a wet area, possibly a spring, which appears from time to time in this area. This may need to be looked at.

7. Consider adding irrigation to the left side and changing the grass species, so it can be played as greens surround, enabling options from lob wedge to a putter if need be.

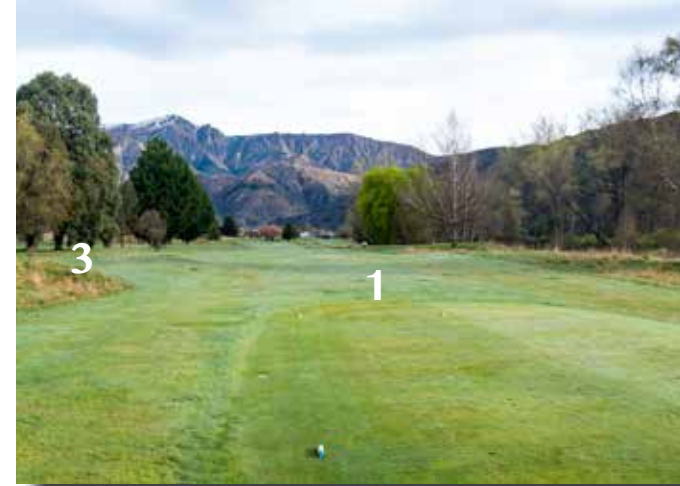
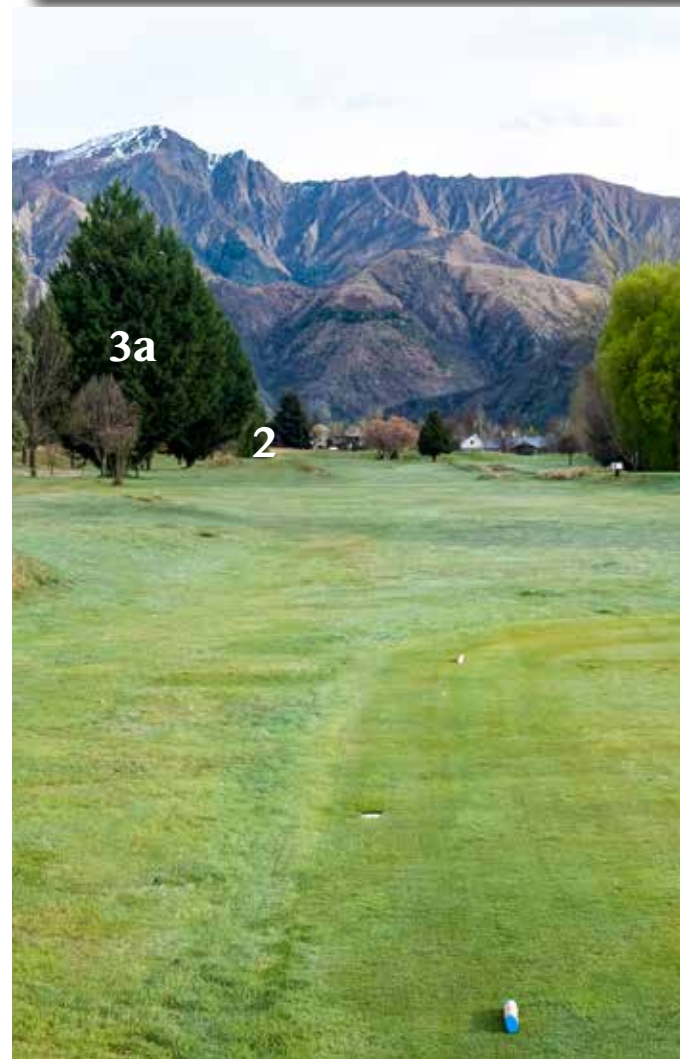
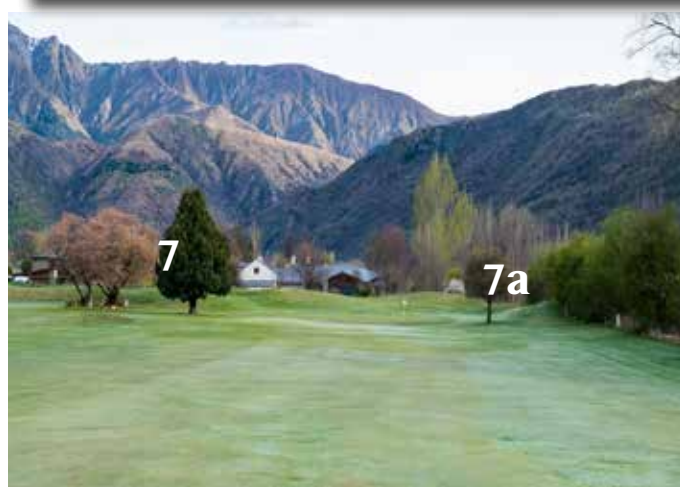
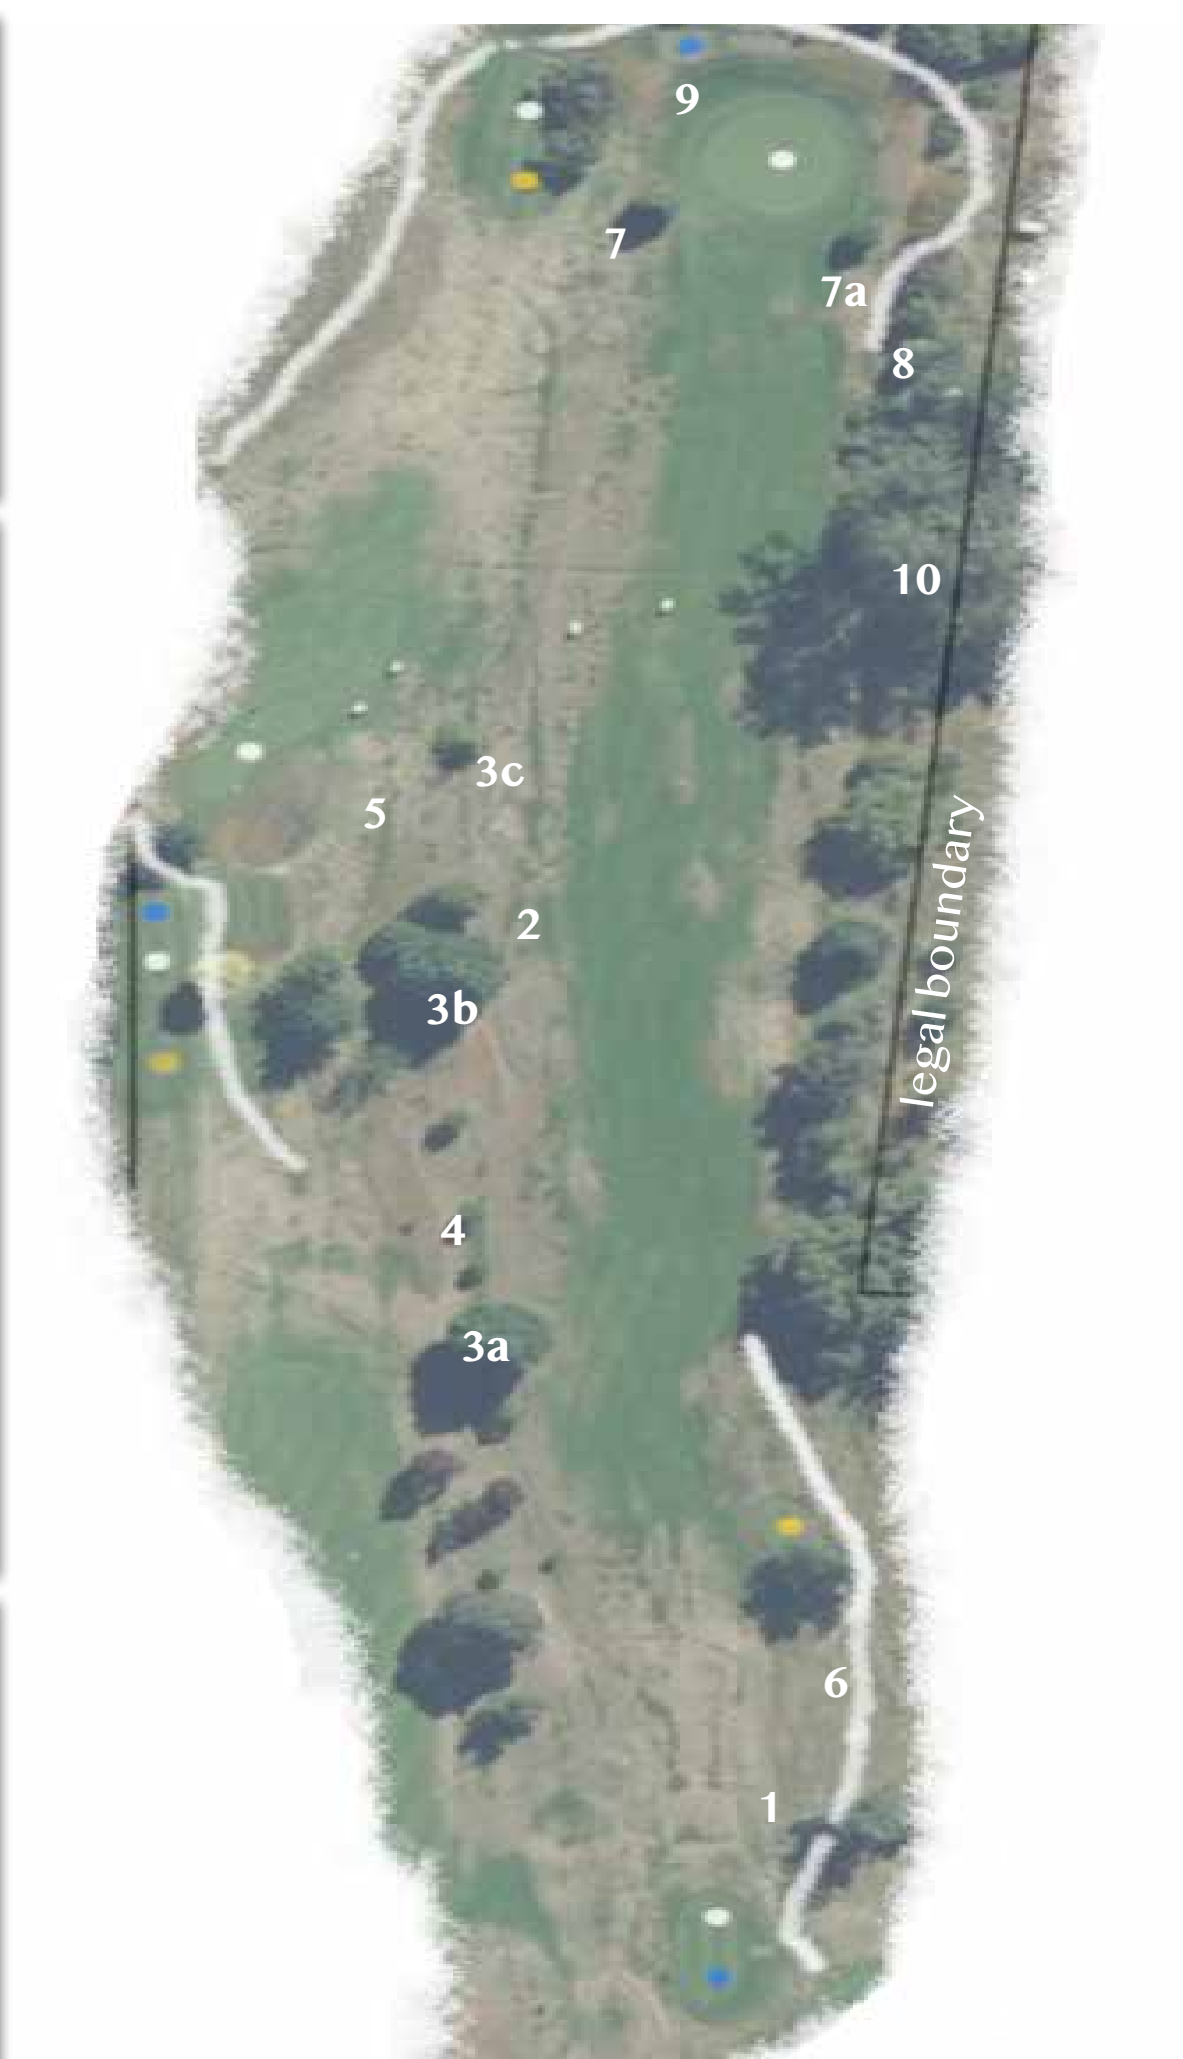
Note - The legal boundary is between 6-12m further to the right than the current fenceline. If the Tewa Banks development proceeds, a new fence line will be built. ALL the trees on the clubs side of the boundary will remain, except the two large black poplars (10).

9. Consider extending short grass surrounds up the mounds towards the proposed cart path.

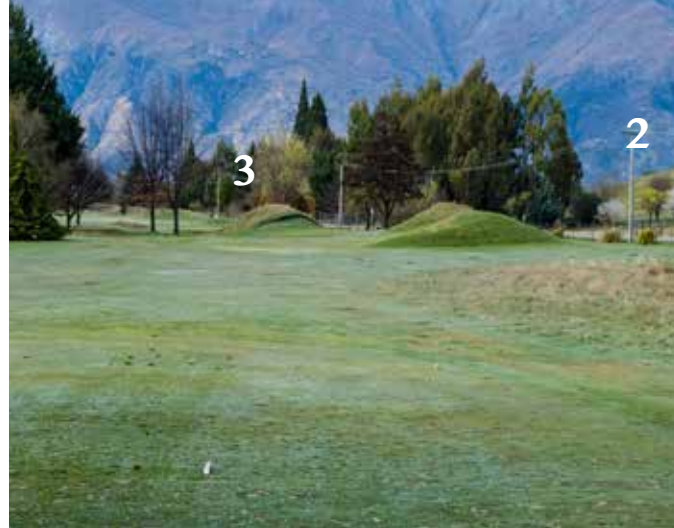
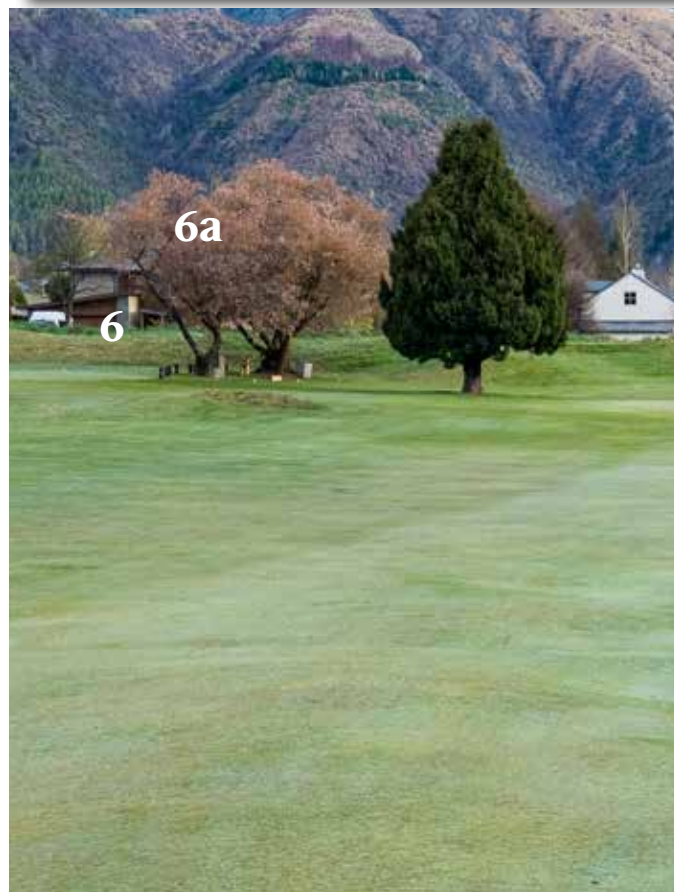
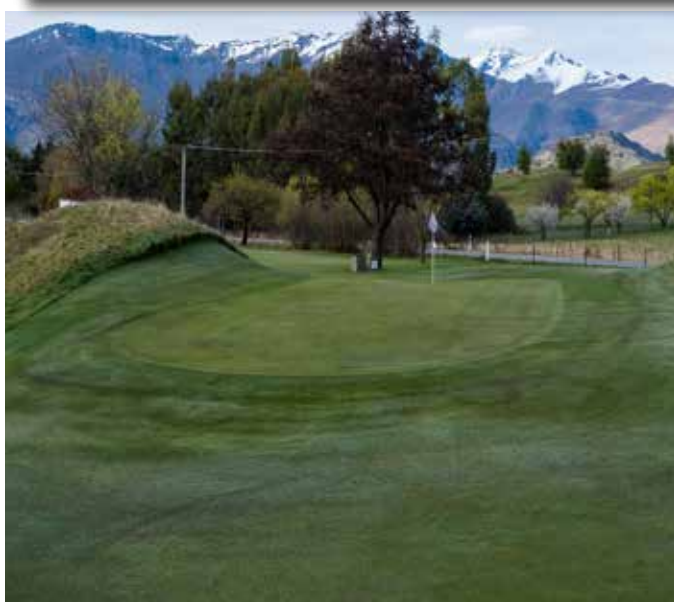
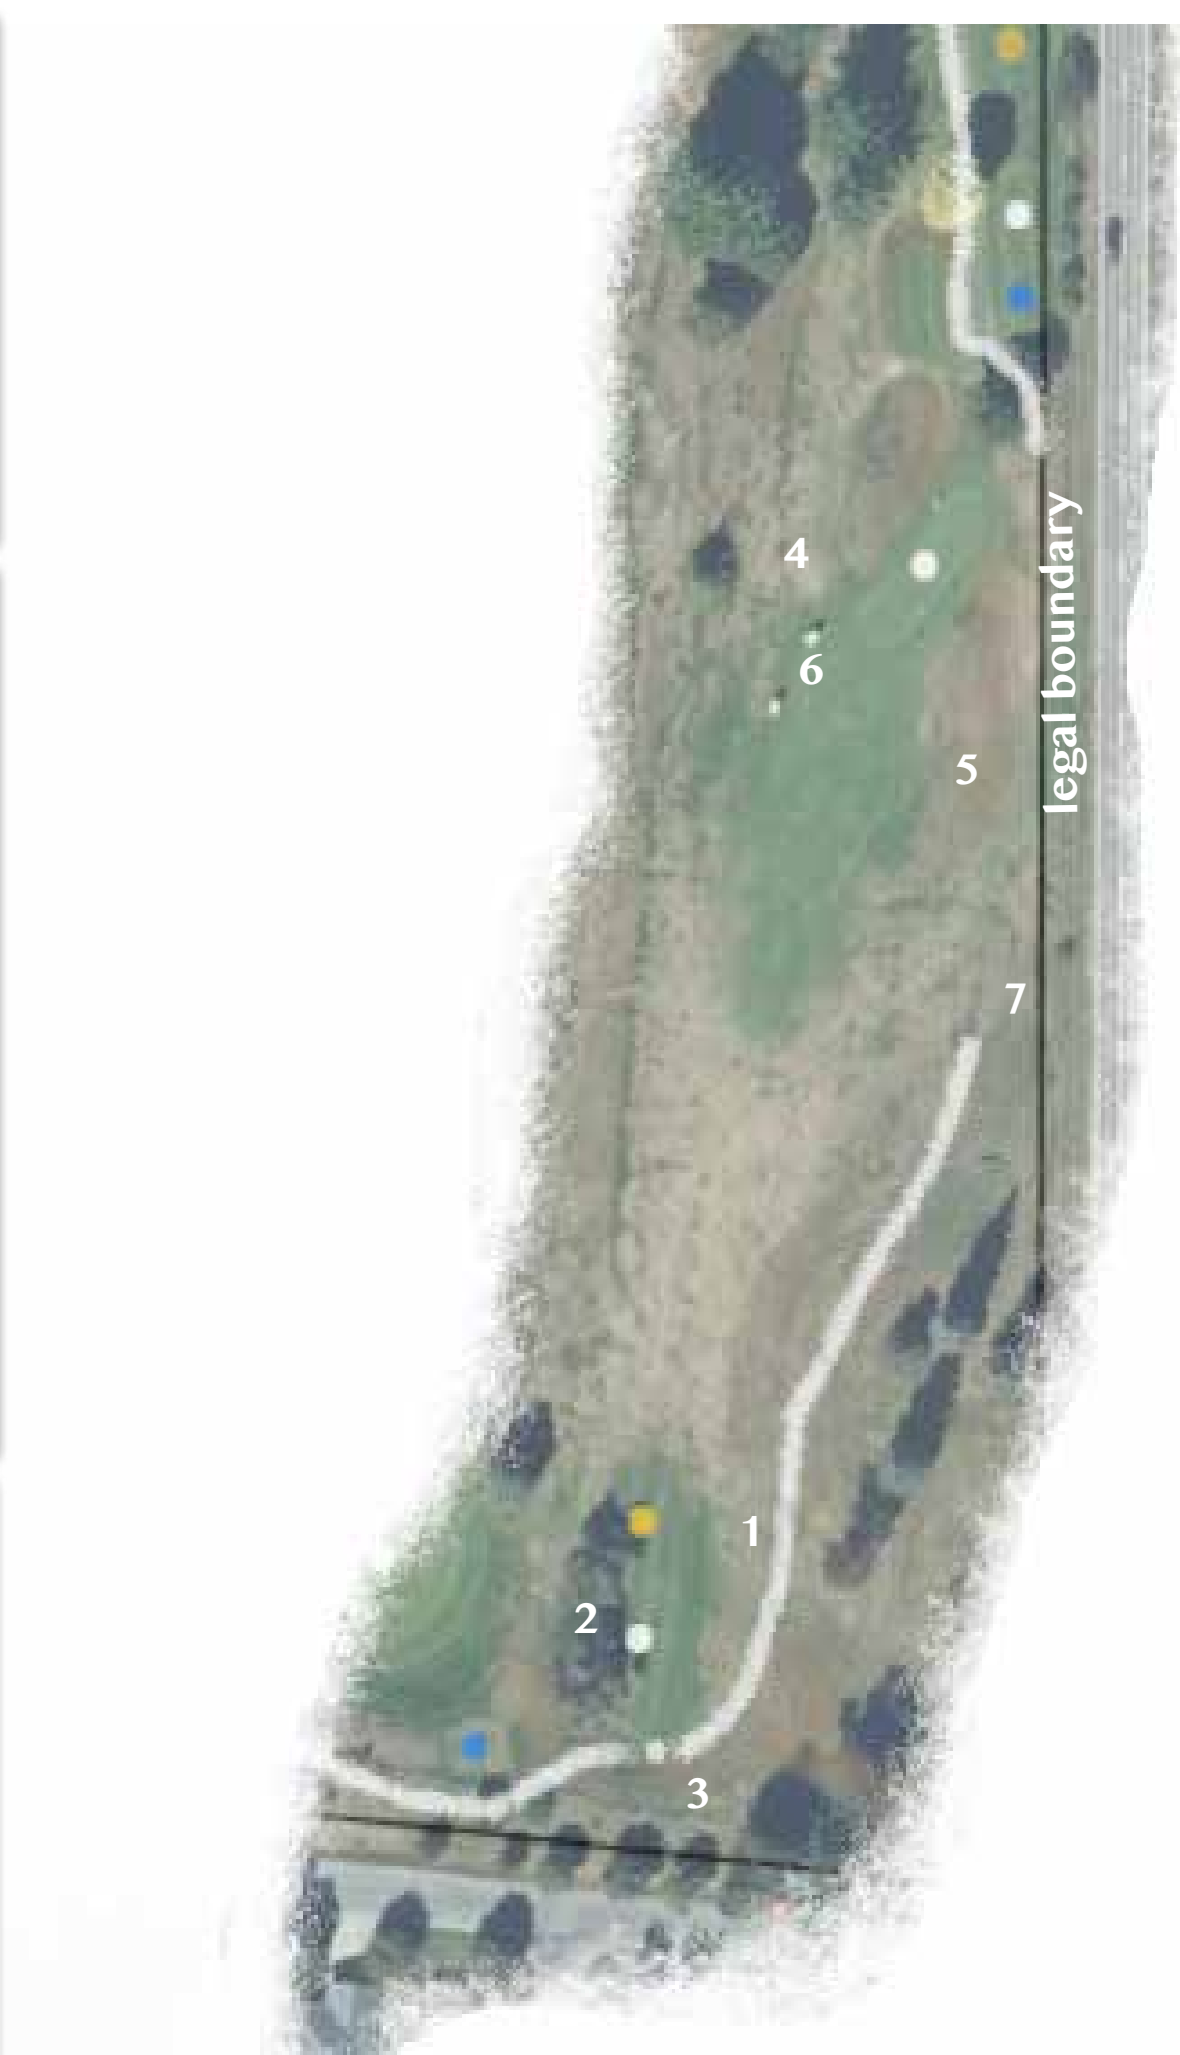
- A tough, demanding par 3. The green is 8m wide in the middle and only 165m2!!
- Two teeing areas : the Blue tee is elevated on a man made mound, the other is flat and on grade with surrounding fairway.
- Two cherry trees provide a bit of shade beside the lower tee in the summertime.
- Timber bollards enclose the green side of the tee. The trees shade mean this area is challenged when it comes to getting vigorous grass growth and accordingly shows a lot of wear and tear from golfer traffic.
- The green is protected by mounds on both left and right and run parallel to the green, which runs at approximately 25-30 degrees to the line of play.
- The road (Out of Bounds) runs behind the green and very much in play.
- The green is a slight 'hogs back' ie the middle is elevated above the front and back.
- Pin positions are limited to effectively a front, middle and back pin.
