Arrowtown
GOLF CLUB

LONG TERM GOLF COURSE PLAN

Final Draft 11 March 2022

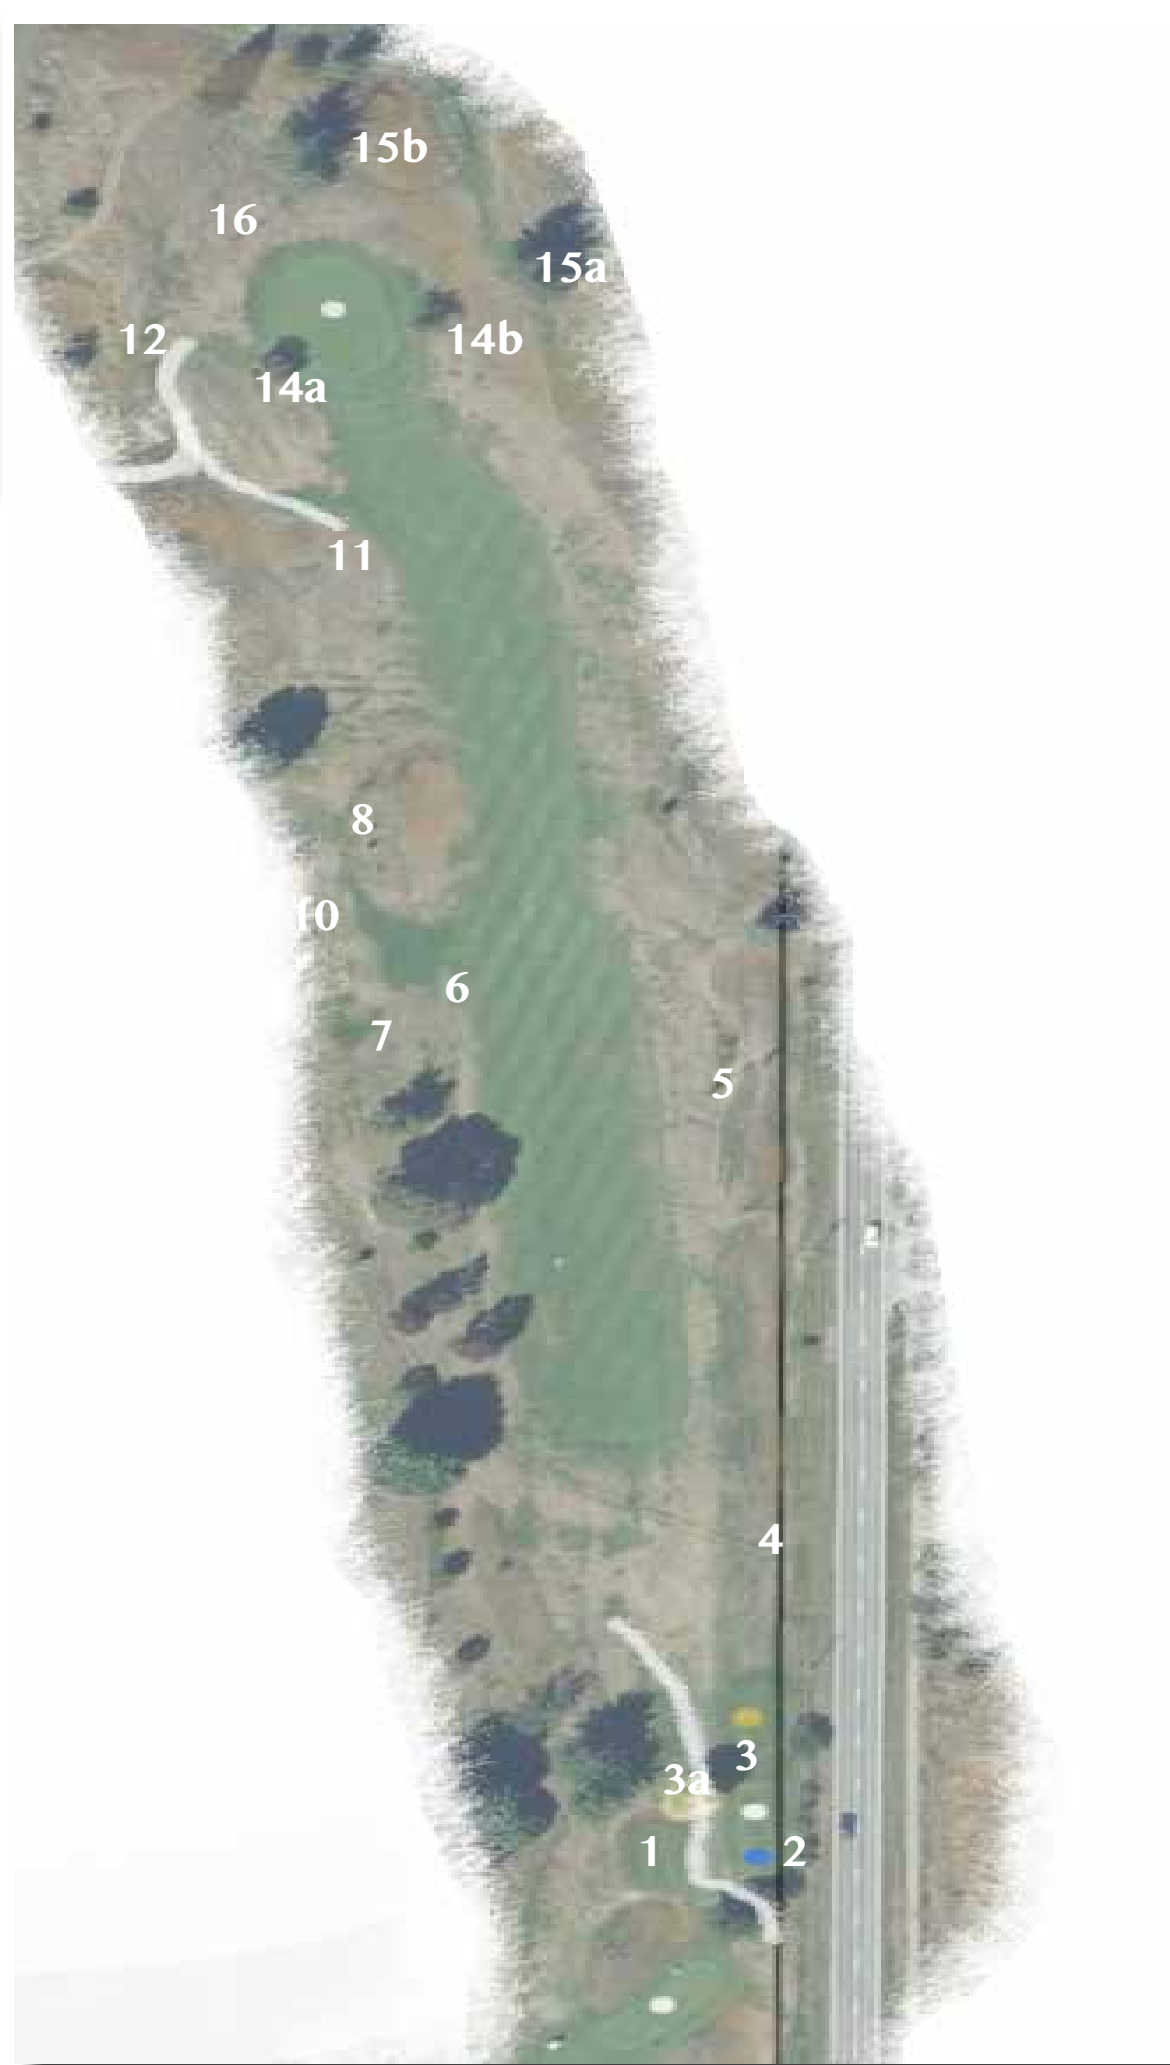
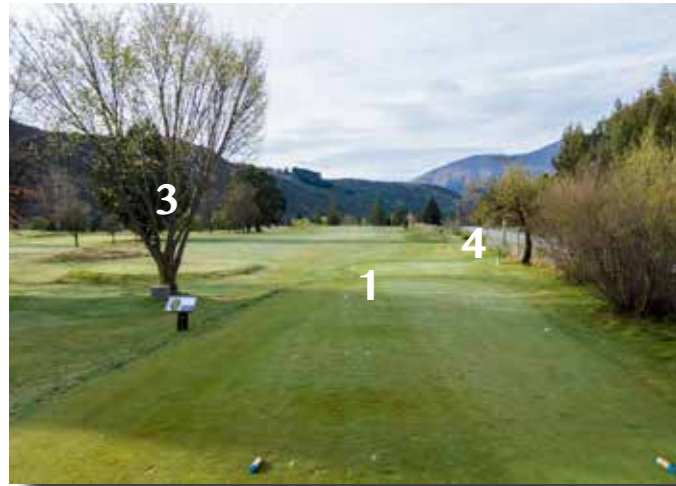
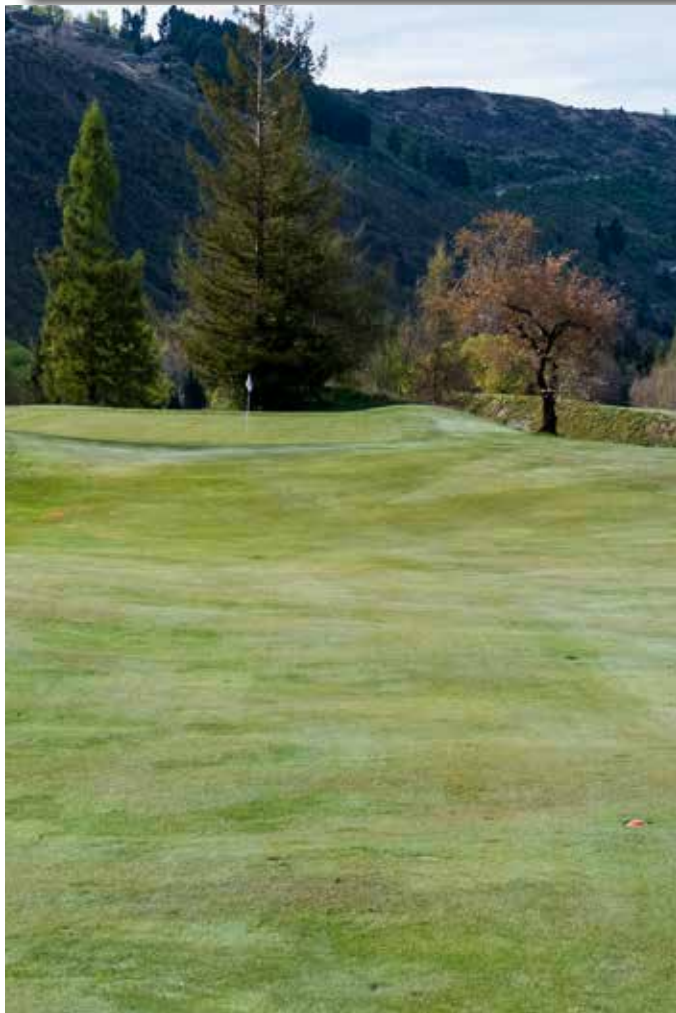
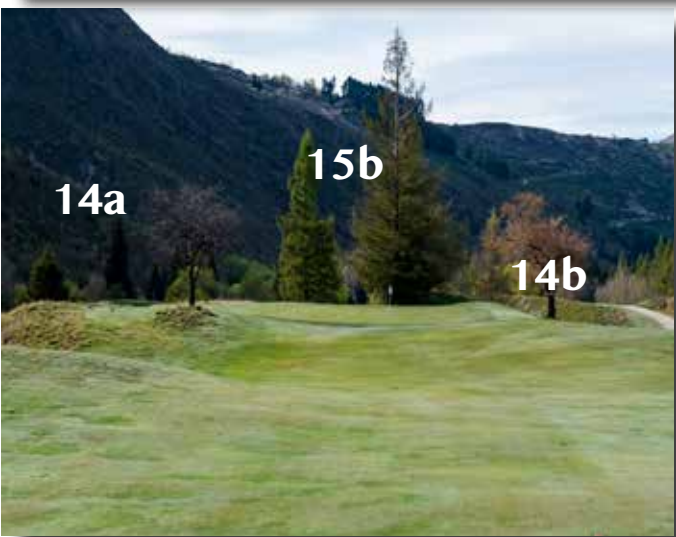
13. The green is flattish with plenty of pin-able green.
14. Remove trees, 14a and 14b..
15. Remove tree in gully (15a) as well as group of conifers behind (15b).

7. Remove the dead kowhais. Do not replace.
8. Continue ongoing removal of the silver birches from the mound.
9. The proposed new 6th tees improve safety from errant tee shots off the 8th as they are further away from the fairway, although it is mostly out of range for most member golfers

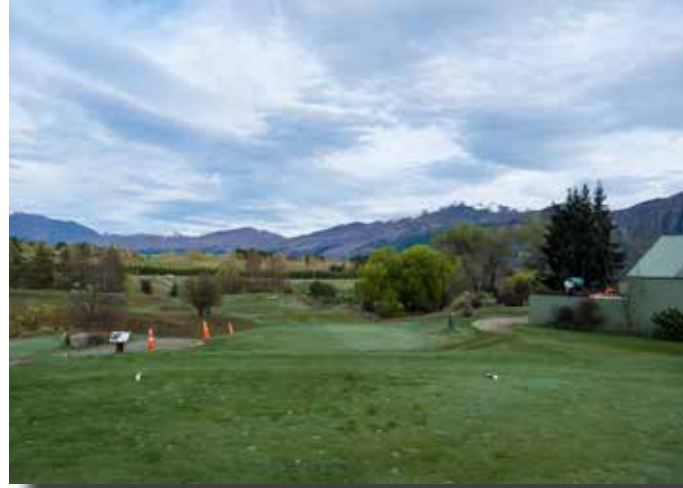
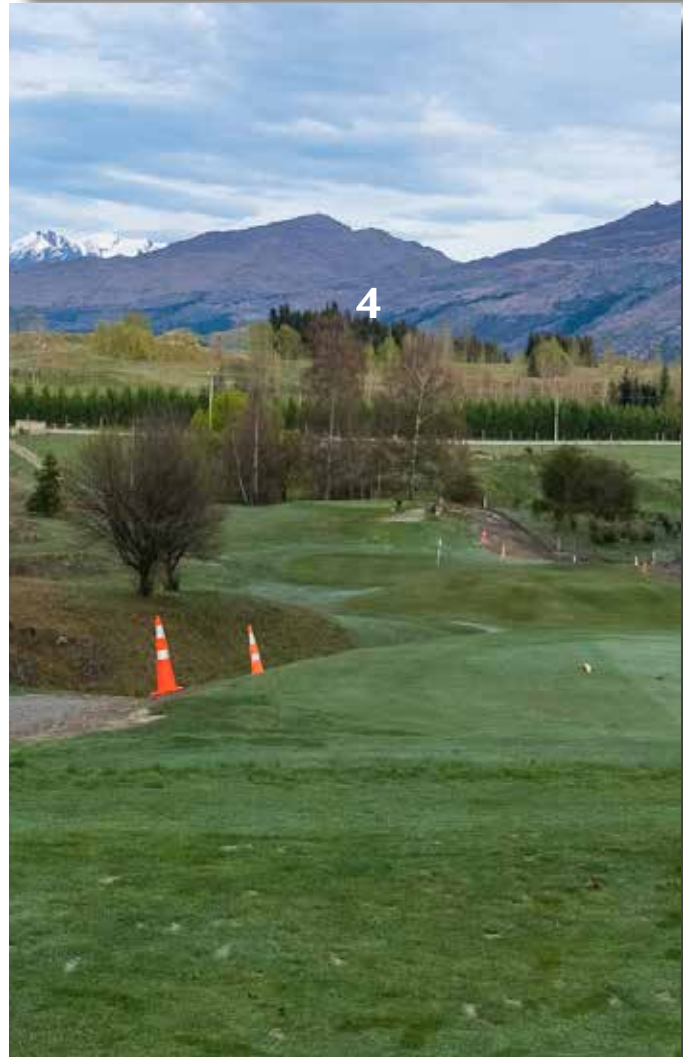
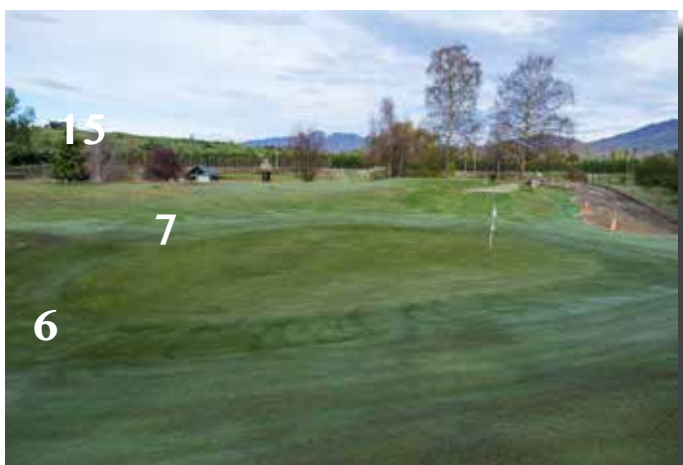
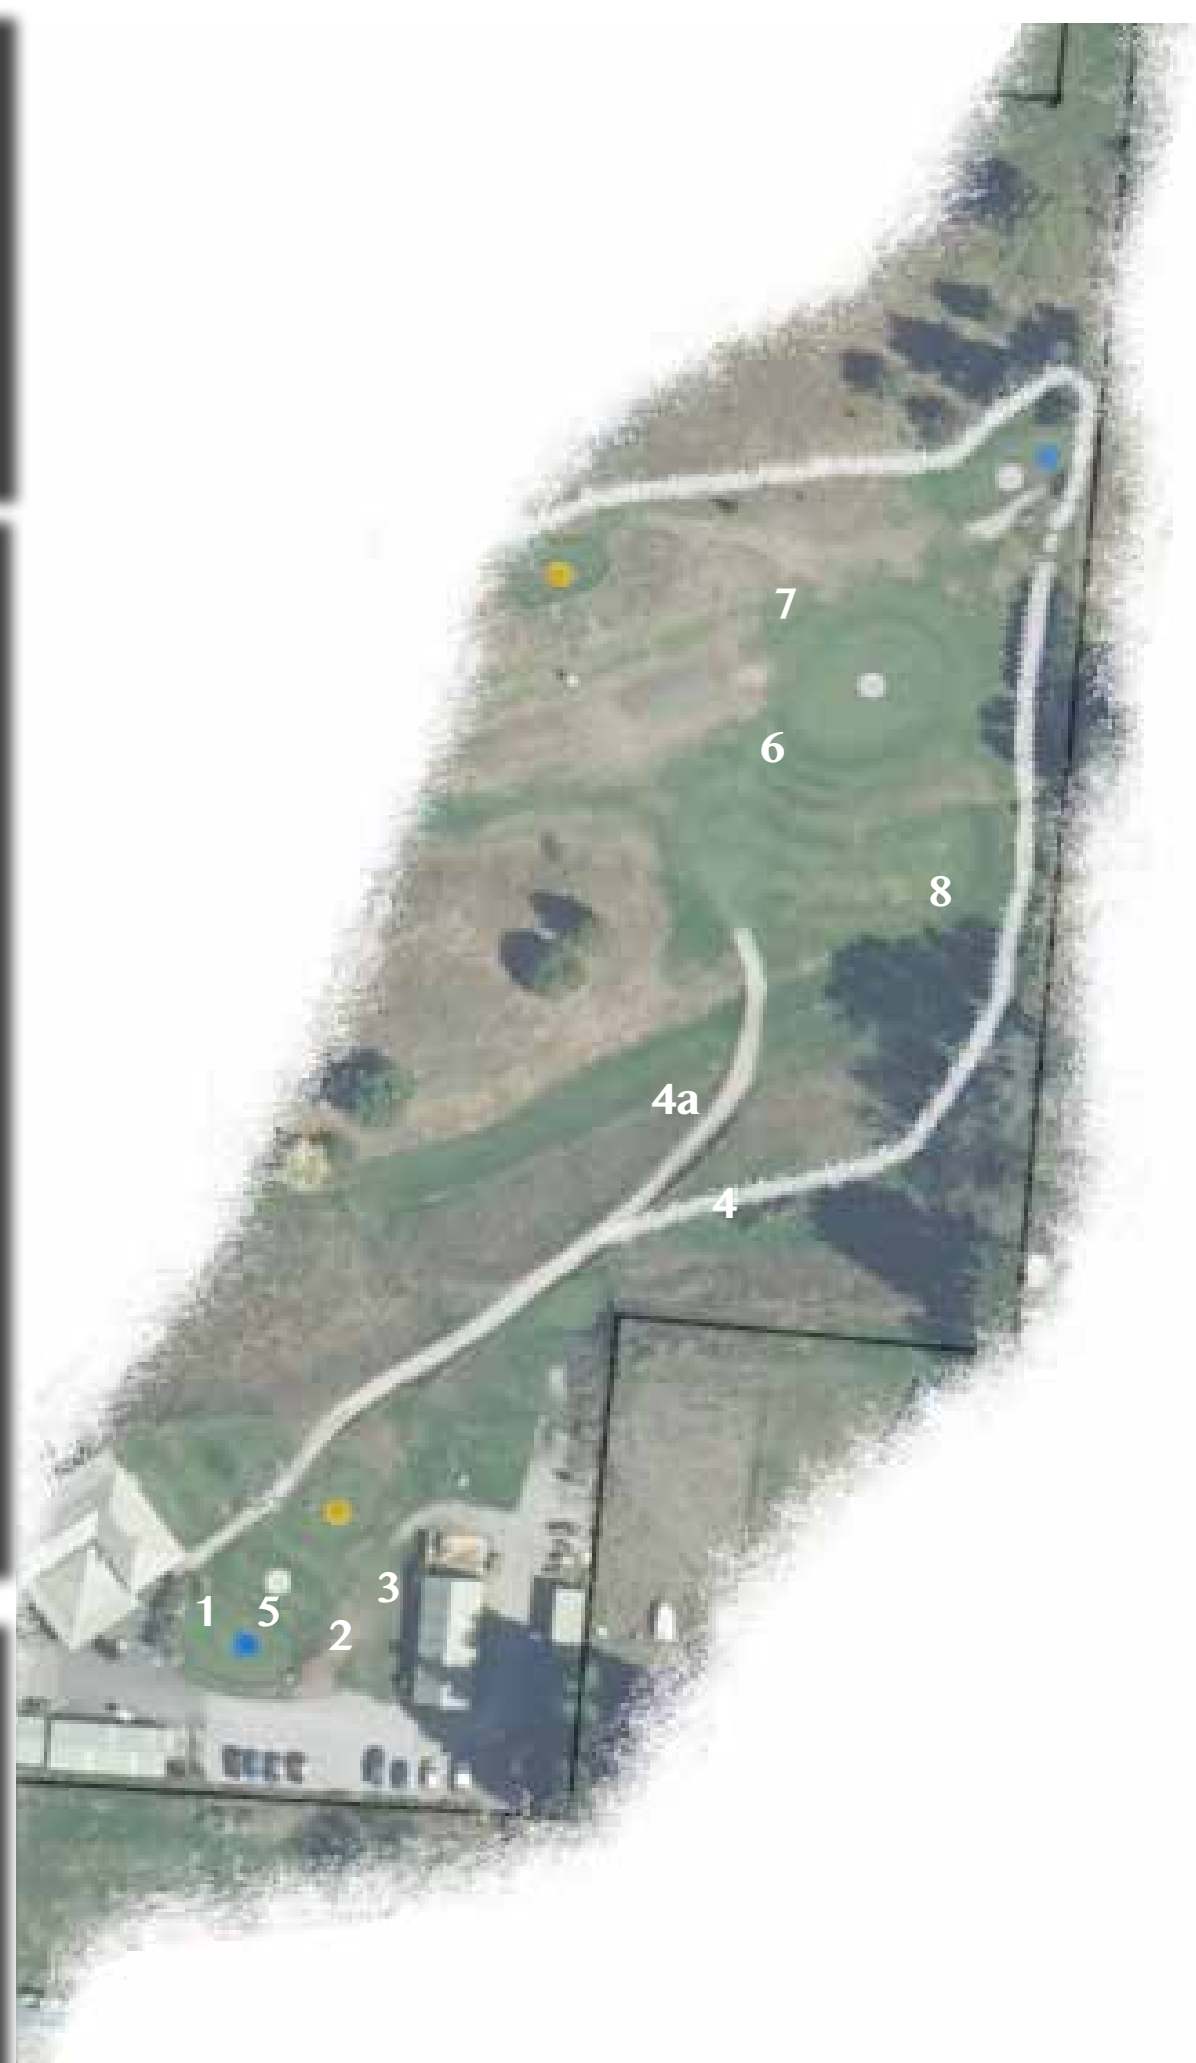
- A medium length, down hill par 3.
- Elevated tees give a good view of the green and surrounds.
- The tees exist on several terraces adding variety in length and angle. teeing area is 381m².
- Out of bounds defines the right side of the hole.
- A strong ridge runs at almost perpendicular to the tee shot. Your tee shot must carry this to reach the green.
- The green is 271m² in area and located in a bowl, of sorts. These two conditions restrict the number of pin positions.
- The cart path is currently cut directly in line with the tee shot, affecting the aesthetic of the golf hole. This has been remedied, refer photos.
- Current cart access is generally around the left side of the green and very close to the putting surface. The agronomy of the surrounds is quite damaged by carts.
- The gully is often wet, mostly in winter. Solutions are needed.

8. Wet area either needs a robust drainage solution or could be planted.

3. Mounding and planting should occur between the new path and maintenance building, to screen the building and compound as much as possible.
4. The path should be continuous from the 1st tee all the way to the second tee, with 'no' cart access off it, this will minimise wear and tear of the grass. Remediate old cart path for the use of the walking golfer only (4a).

6. The new path and control of cart circulation, would allow an increase in the green size to the left side and with it a few more pin placements.
7. Irregular conditions in ground levels and agronomy in the surrounds, particularly at the back of the green, could be remedied.

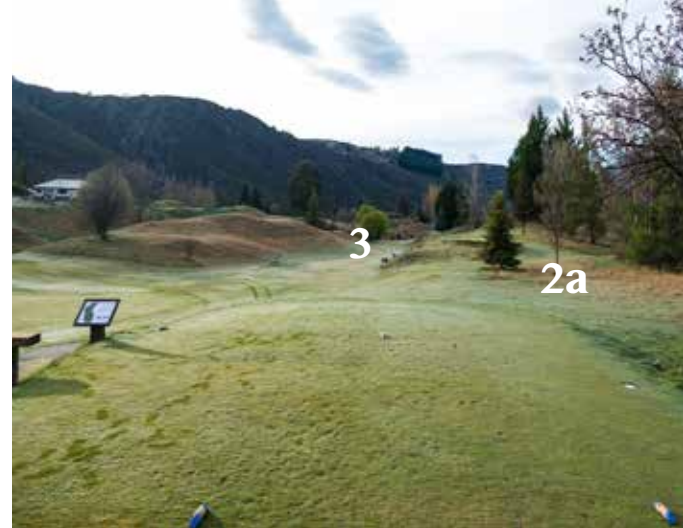
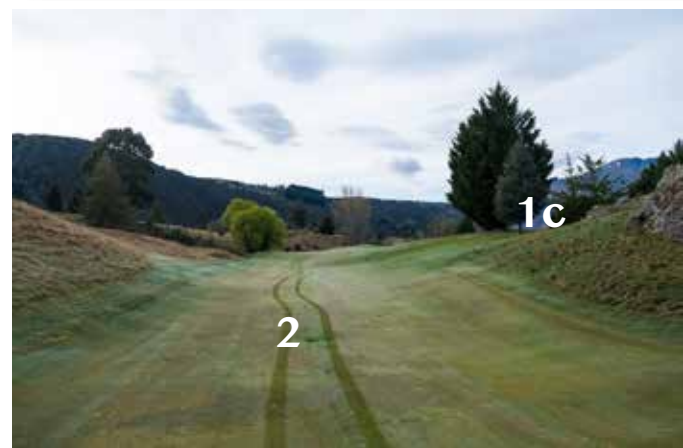
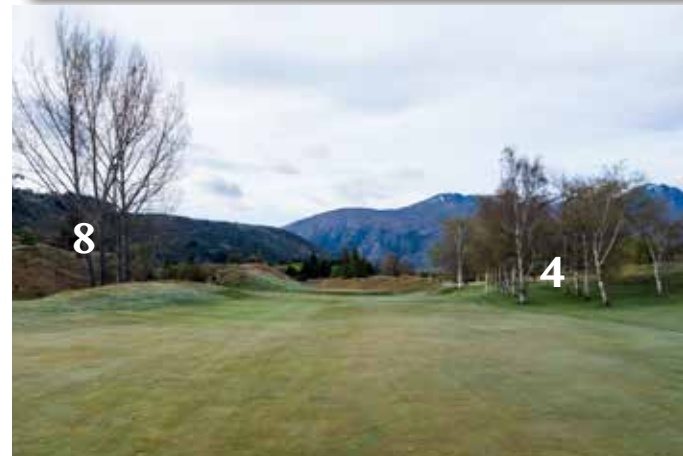
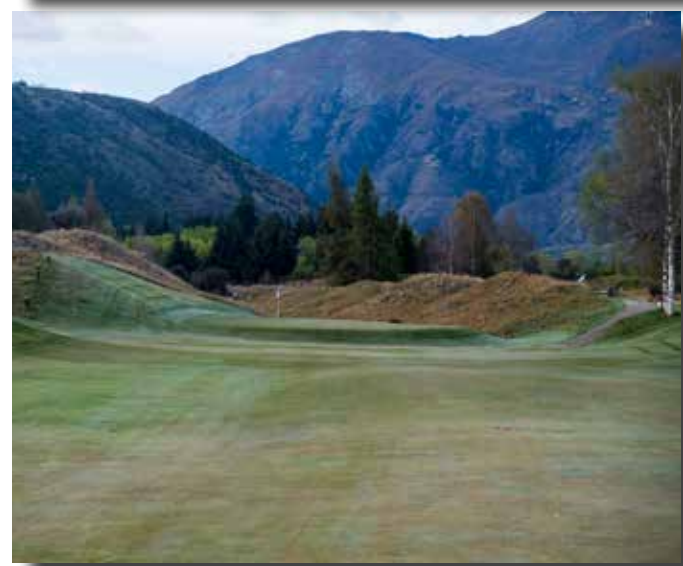
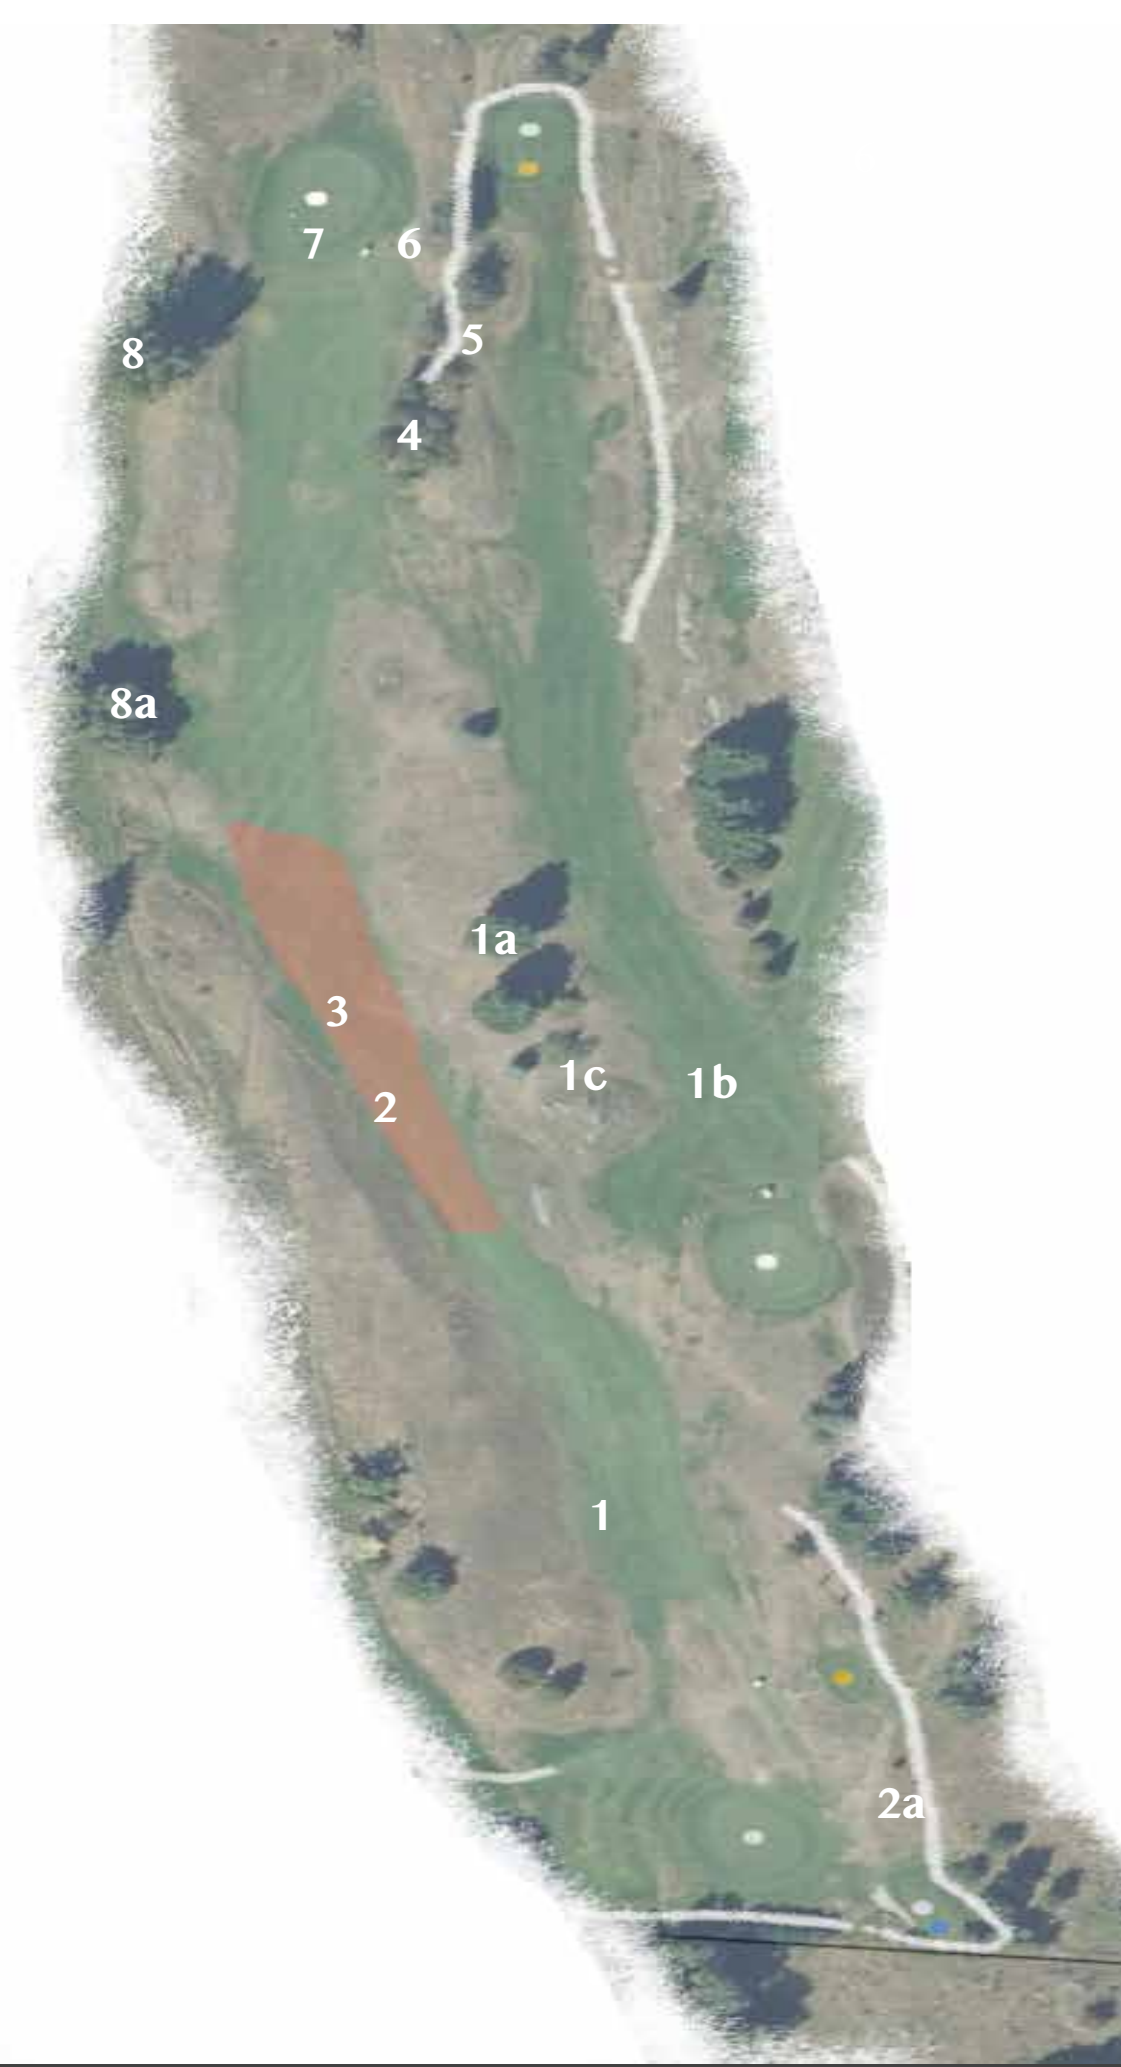
- A medium length par 5 and the only one on the back 9.
- 'Arrowtown' personified and a great driving hole.
- Two small teeing areas are positioned on a ridge. The teeing areas are 210m², second smallest on the golf course, this limits options to adjust tee position and spread the wear and tear on the fairway.

- The fairway is defined by dry ridges either side of the fairway.
- A lateral hazard is present on the left (but not really visible) and a line of trees on the right at 200m-250m, to protect the 3rd fairway from the second shot.

2. The valley nature of the fairway landing zone means it gathers golf ball into a small area of wear and tear. I suggest extending the tee by another 45m (2a). This should, on average spread the wear and tear on the fairway in line with the tee placement. It would move the risk of the 'miss' on the 12th fairway closer toward the 12th tee. It will also change the angle of play, the golfer will tend to aim a little bit more left. (Requires discussion)

4. Birch trees beside 11th green are of limited safety and of no strategic value I recommend some be removed.
5. Reposition cart path where the birches are, which is quite high and out of the fairway. Upgrade cart path to hard surface.

6. Remove old cart path and fix the drainage, this should enable better quality agronomy and a wider surround of short grass as it would only services the walking golfer.

7. A discussion needs to be held on rebuilding the green, in line with the courses 'style'.
8. The poplars are near the 'use by' date and should be on the list for removal. NB. There's a broader discussion around safety on the 10th, 11th, 12th and 13th all of which effect each other and would like to discuss in the field.
